Unlined Construction and Demolition Debris Disposal Facilities

Dawn Templin, P.E.
Alex Webster, P.G.
Northwest District

Florida Department of Environmental Protection

Pensacola, FL | June 16, 2023

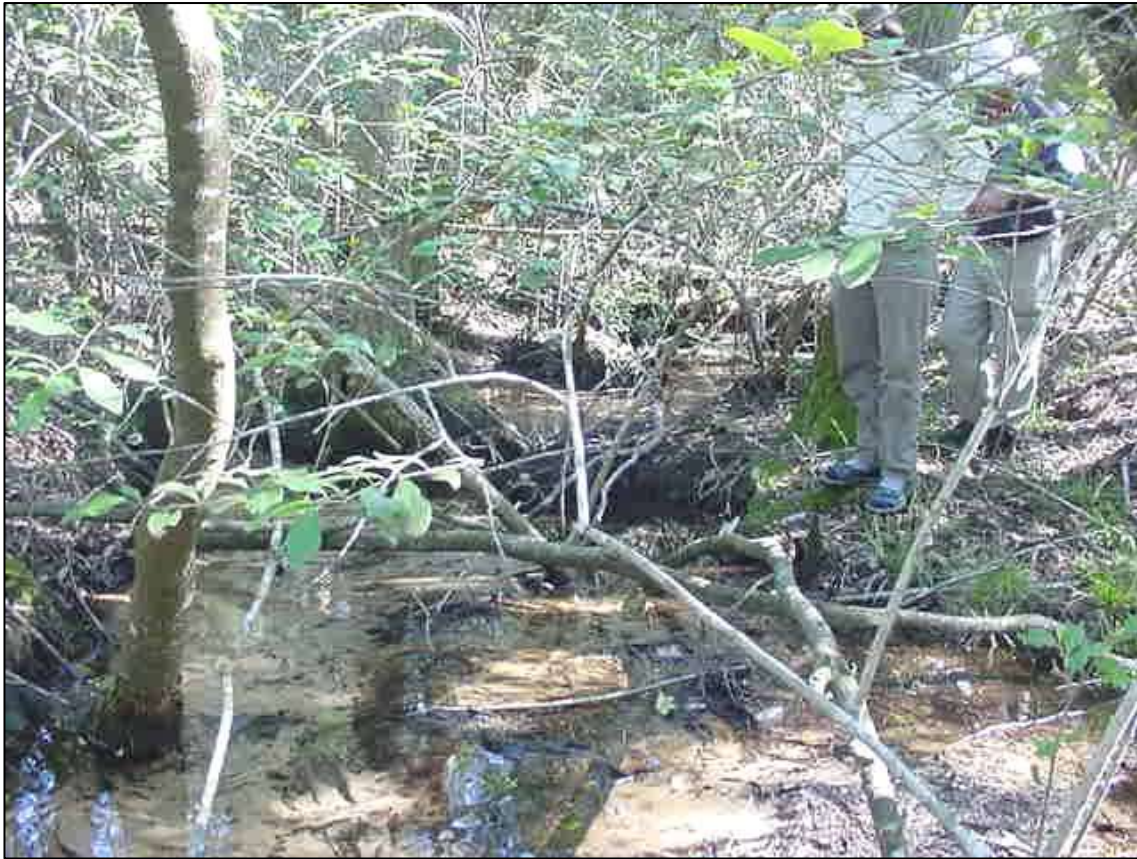
Upstream

Groundwater contamination can cause surface water contamination.

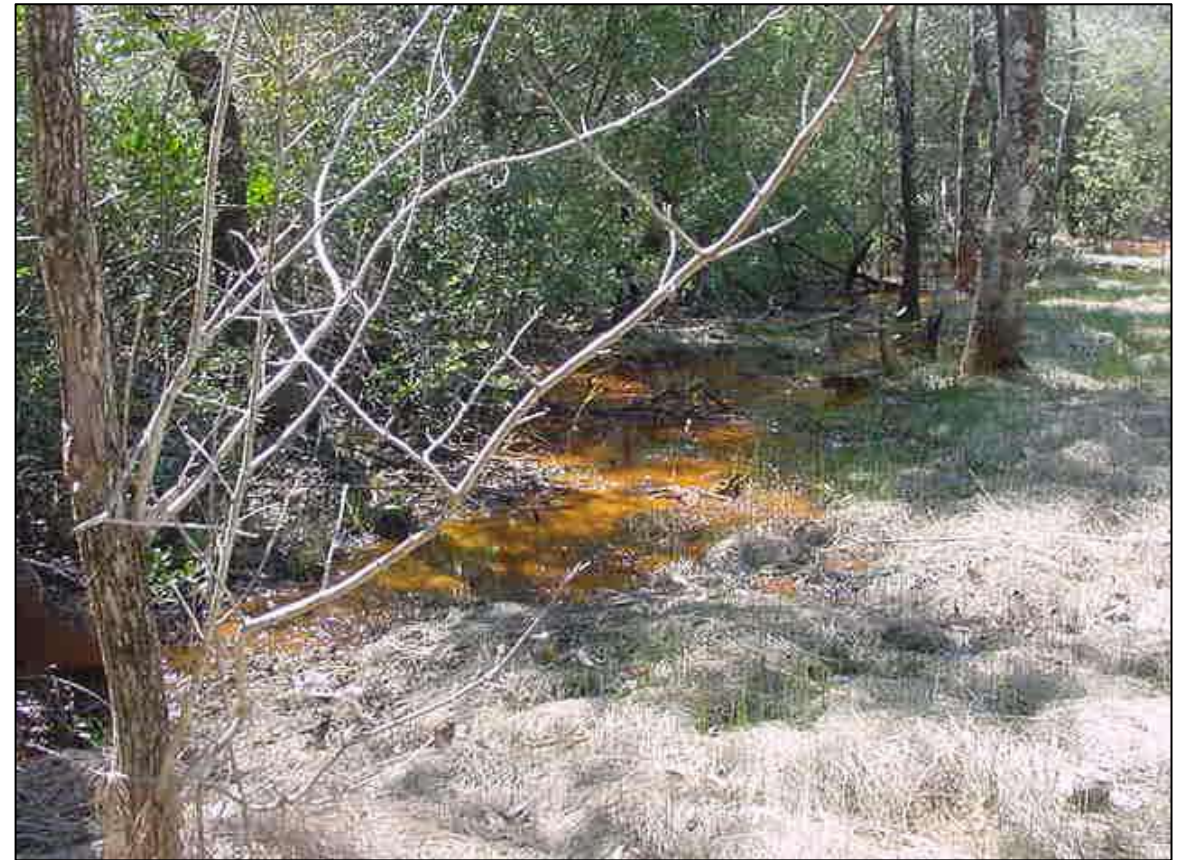
Downstream

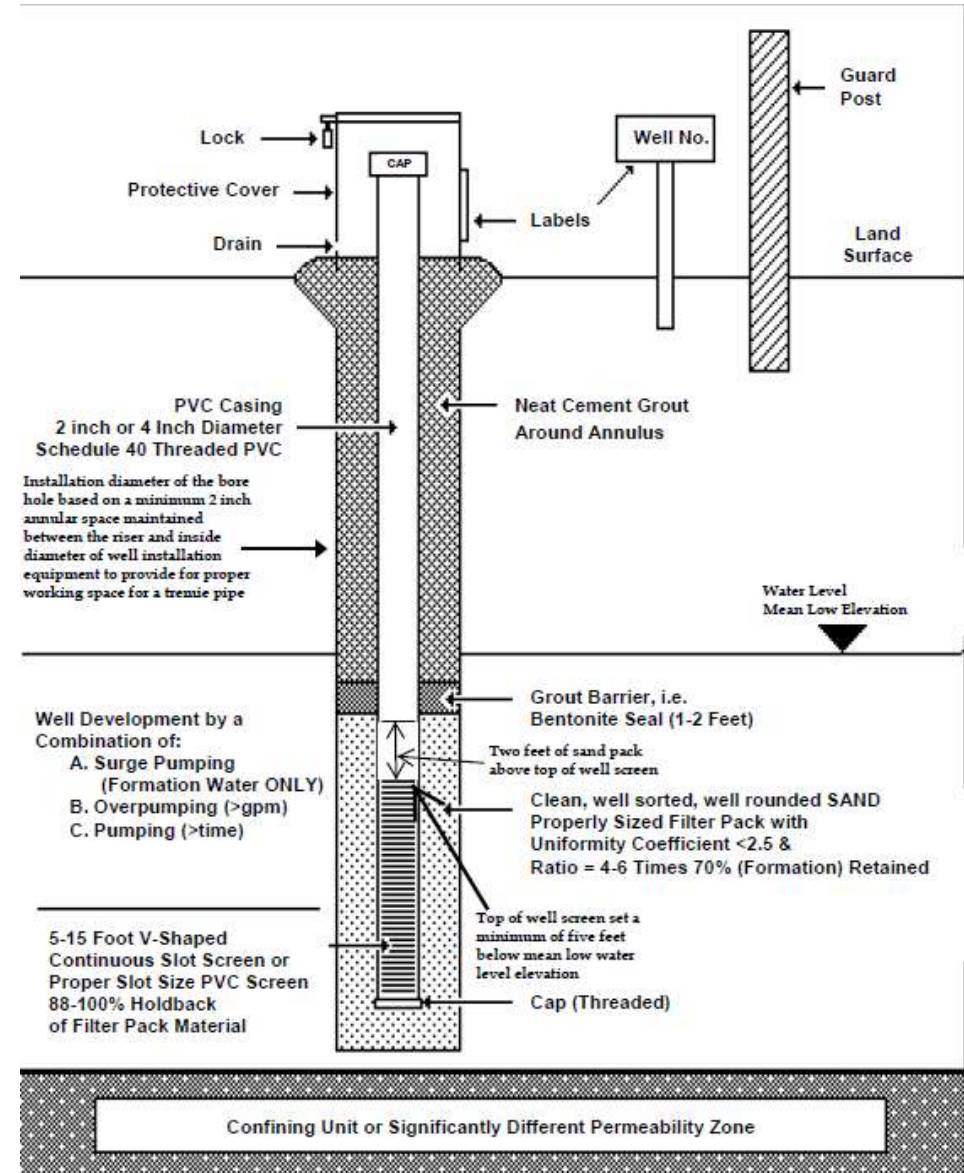
- **Construction:**
 - Well screens
 - Location
 - Floridan wells
- **Sampling techniques:**
 - One well volume versus equipment volume

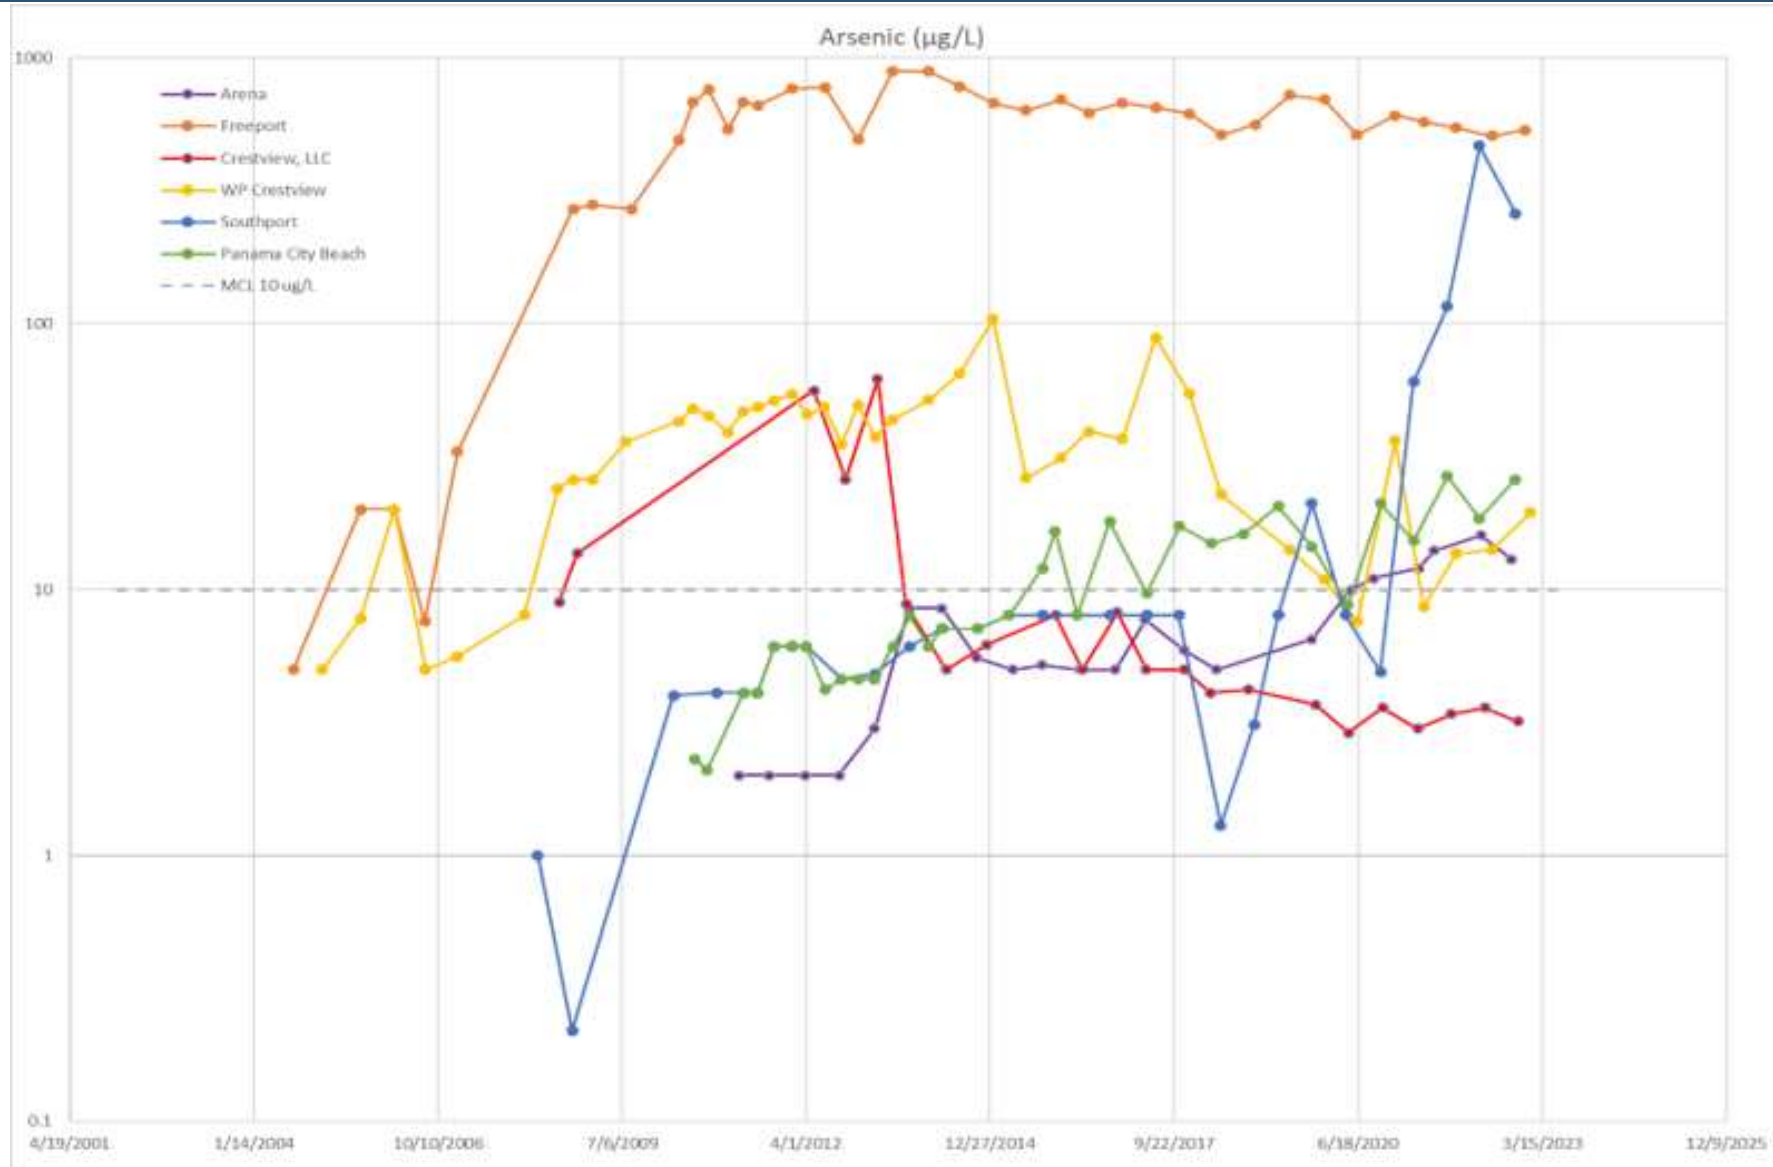
Arsenic at C&Ds

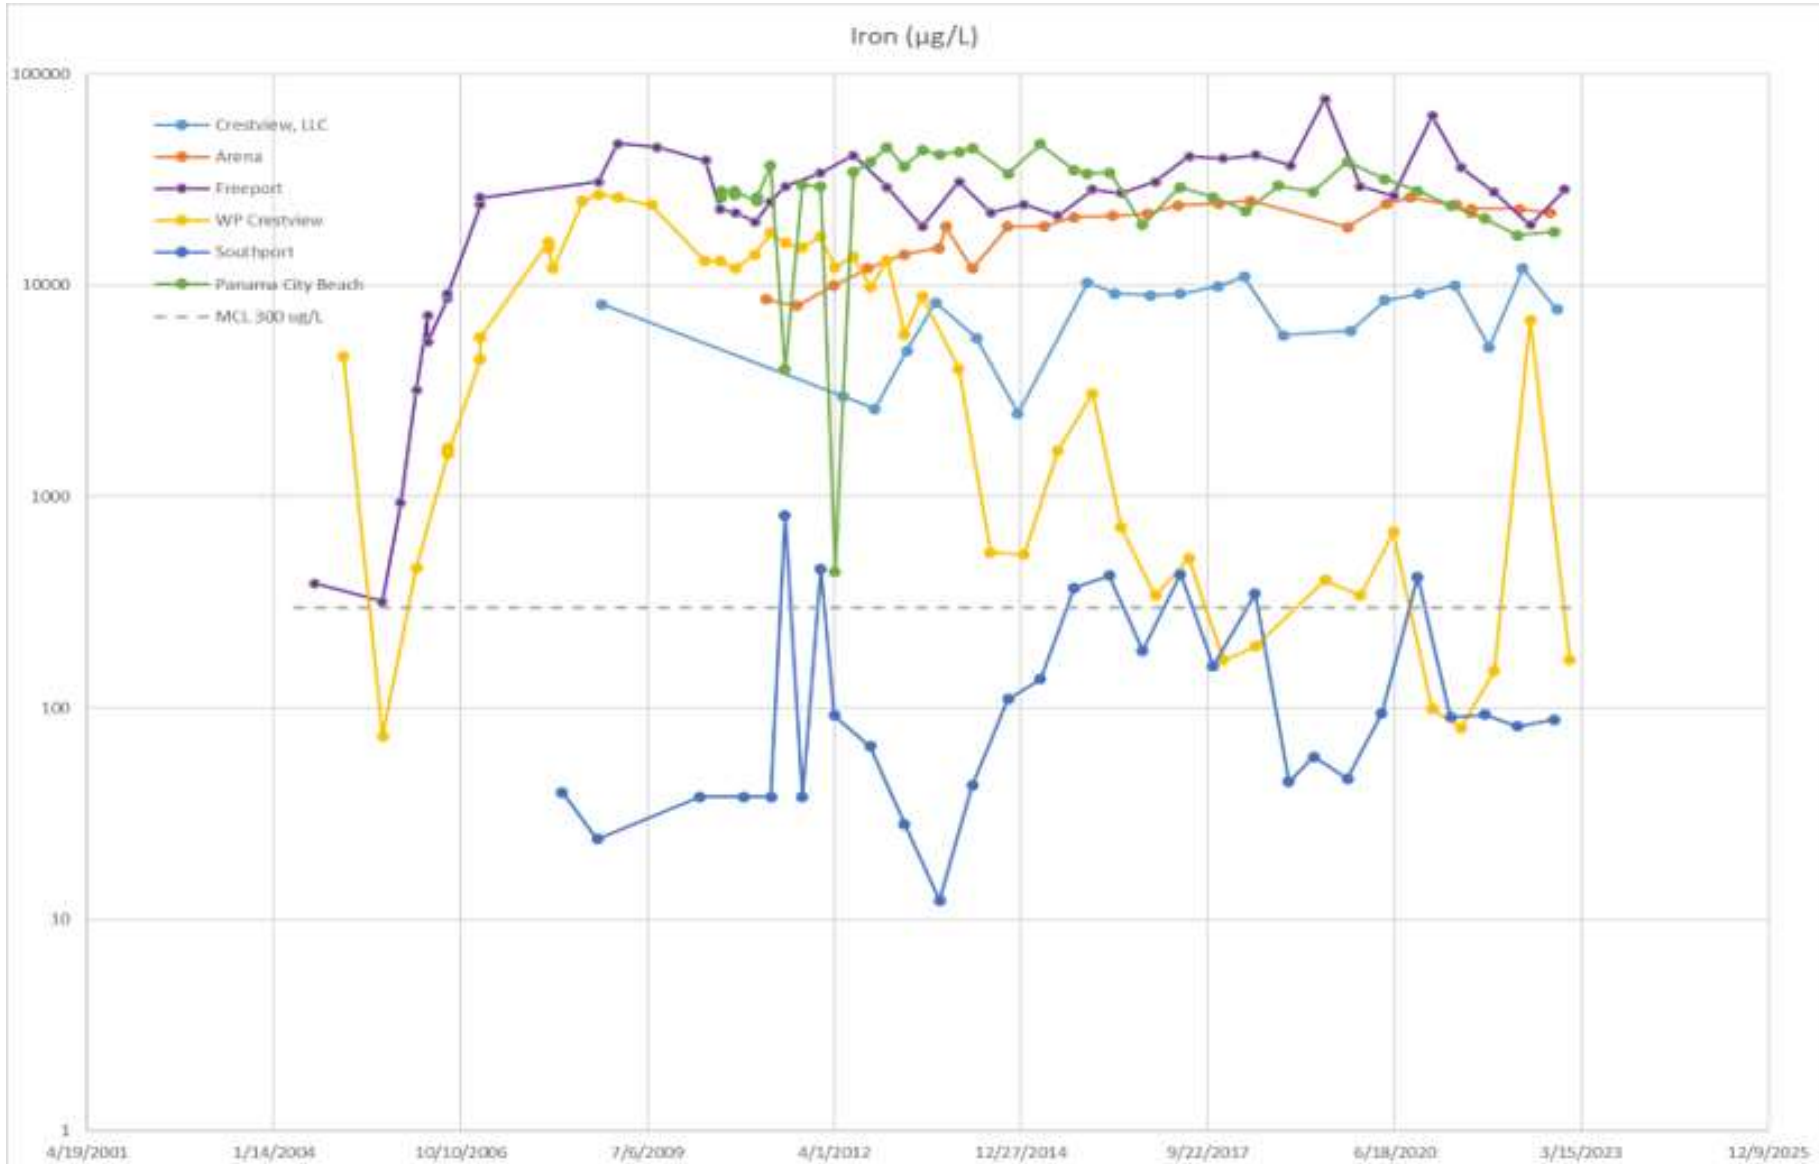
Iron at C&Ds

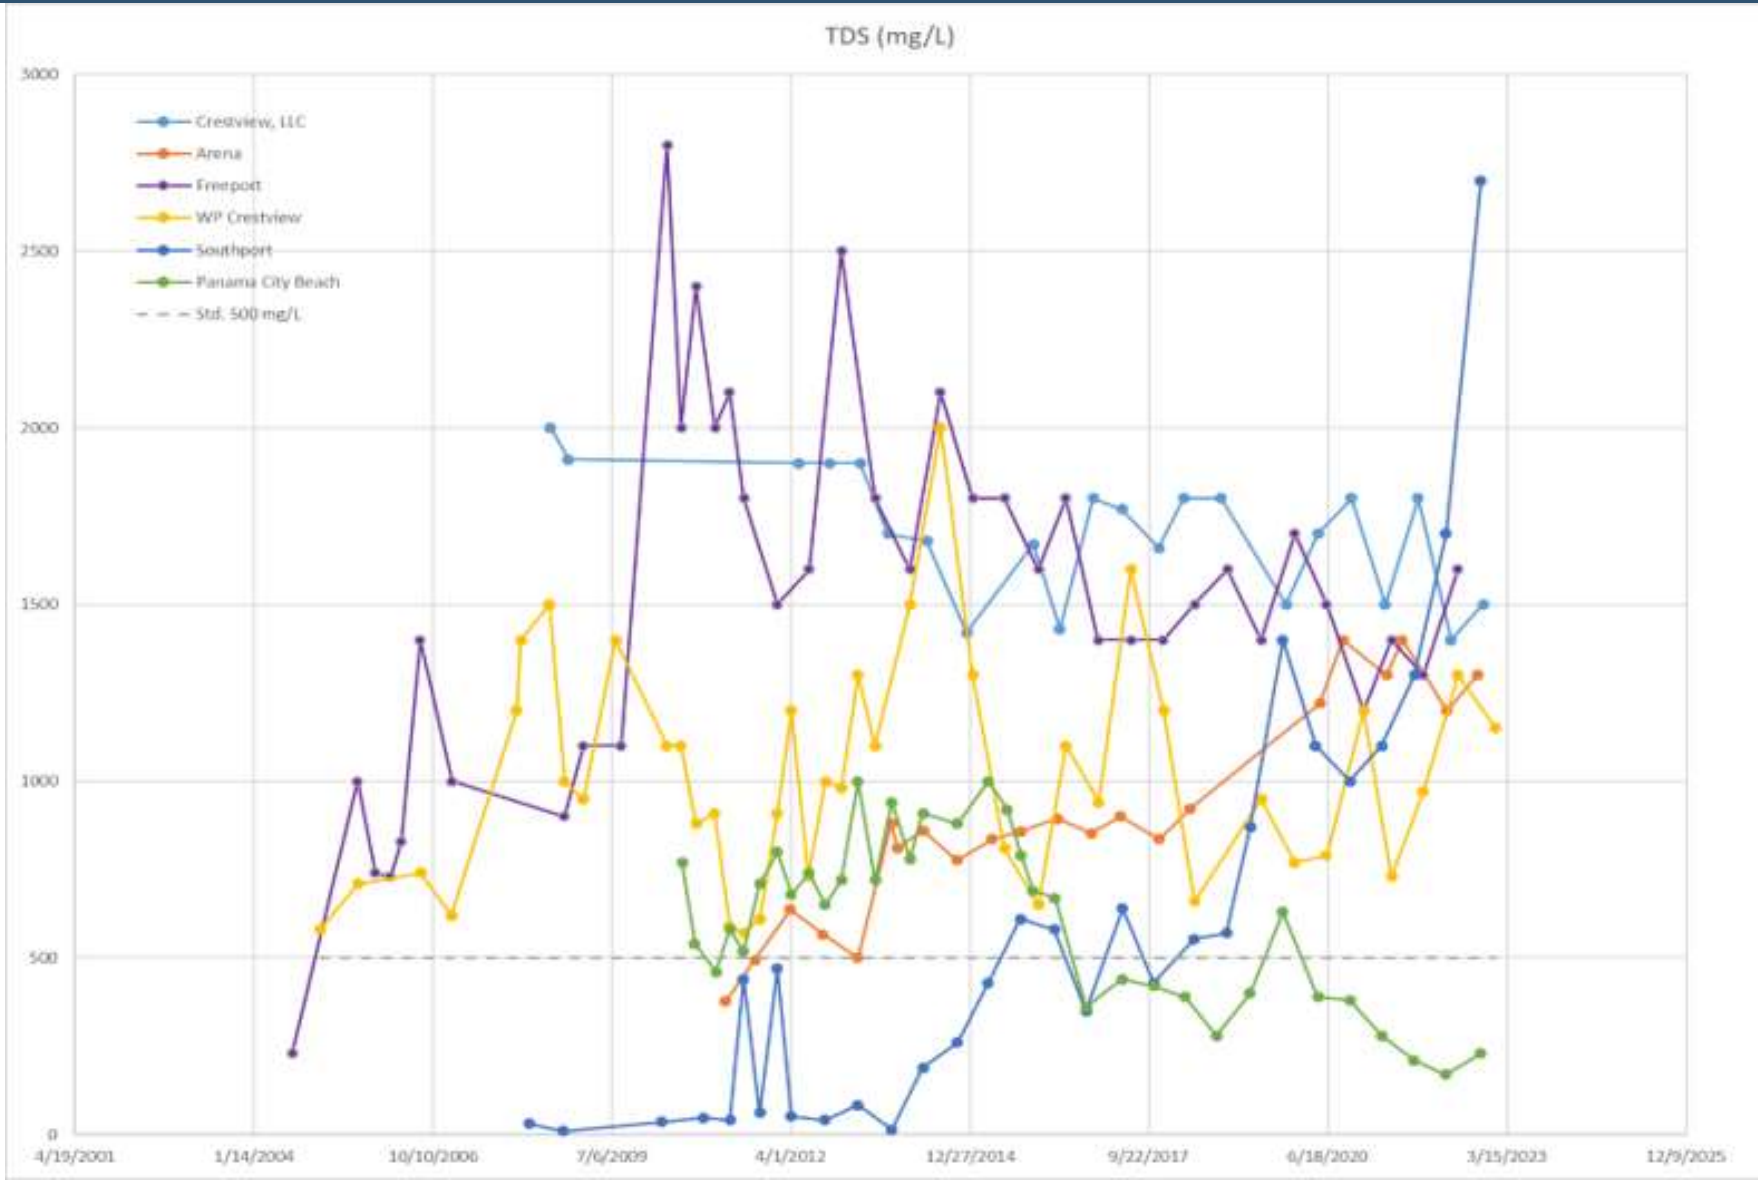
Total Dissolved Solids (TDS) at C&Ds

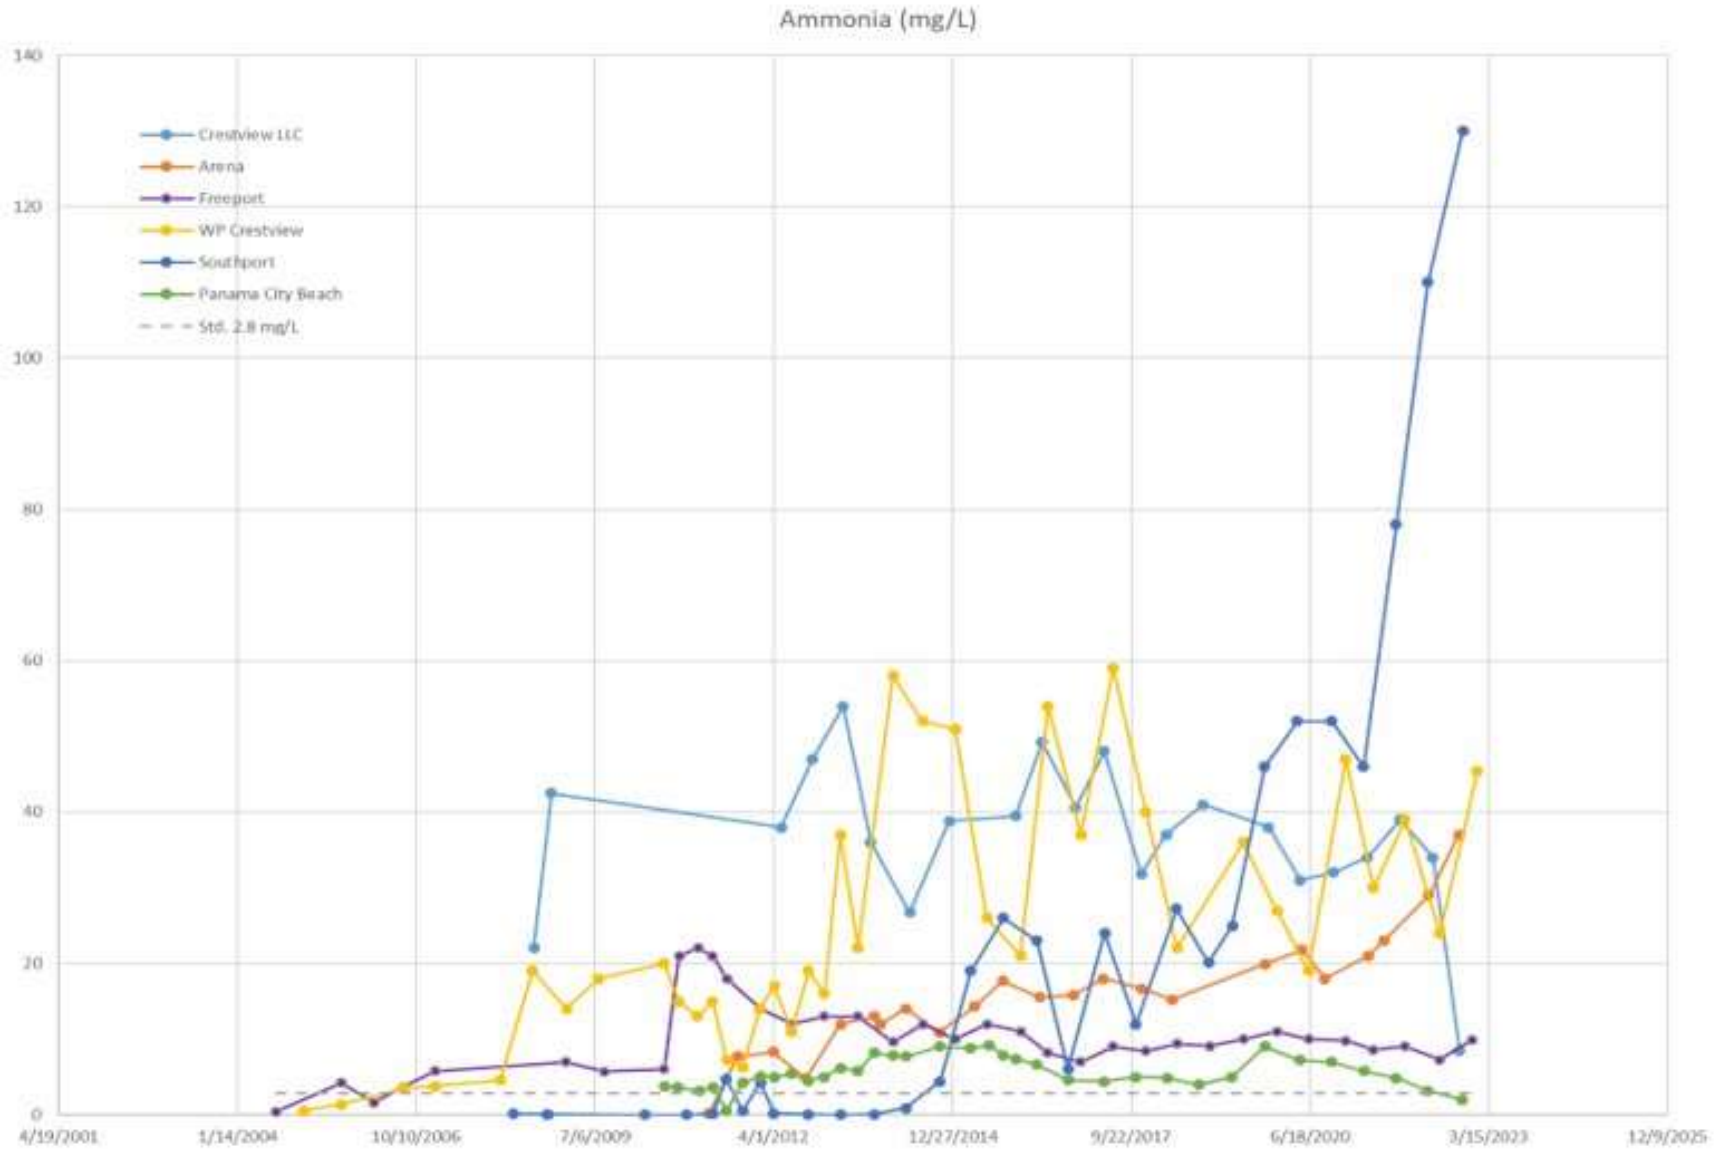
Ammonia at C&Ds

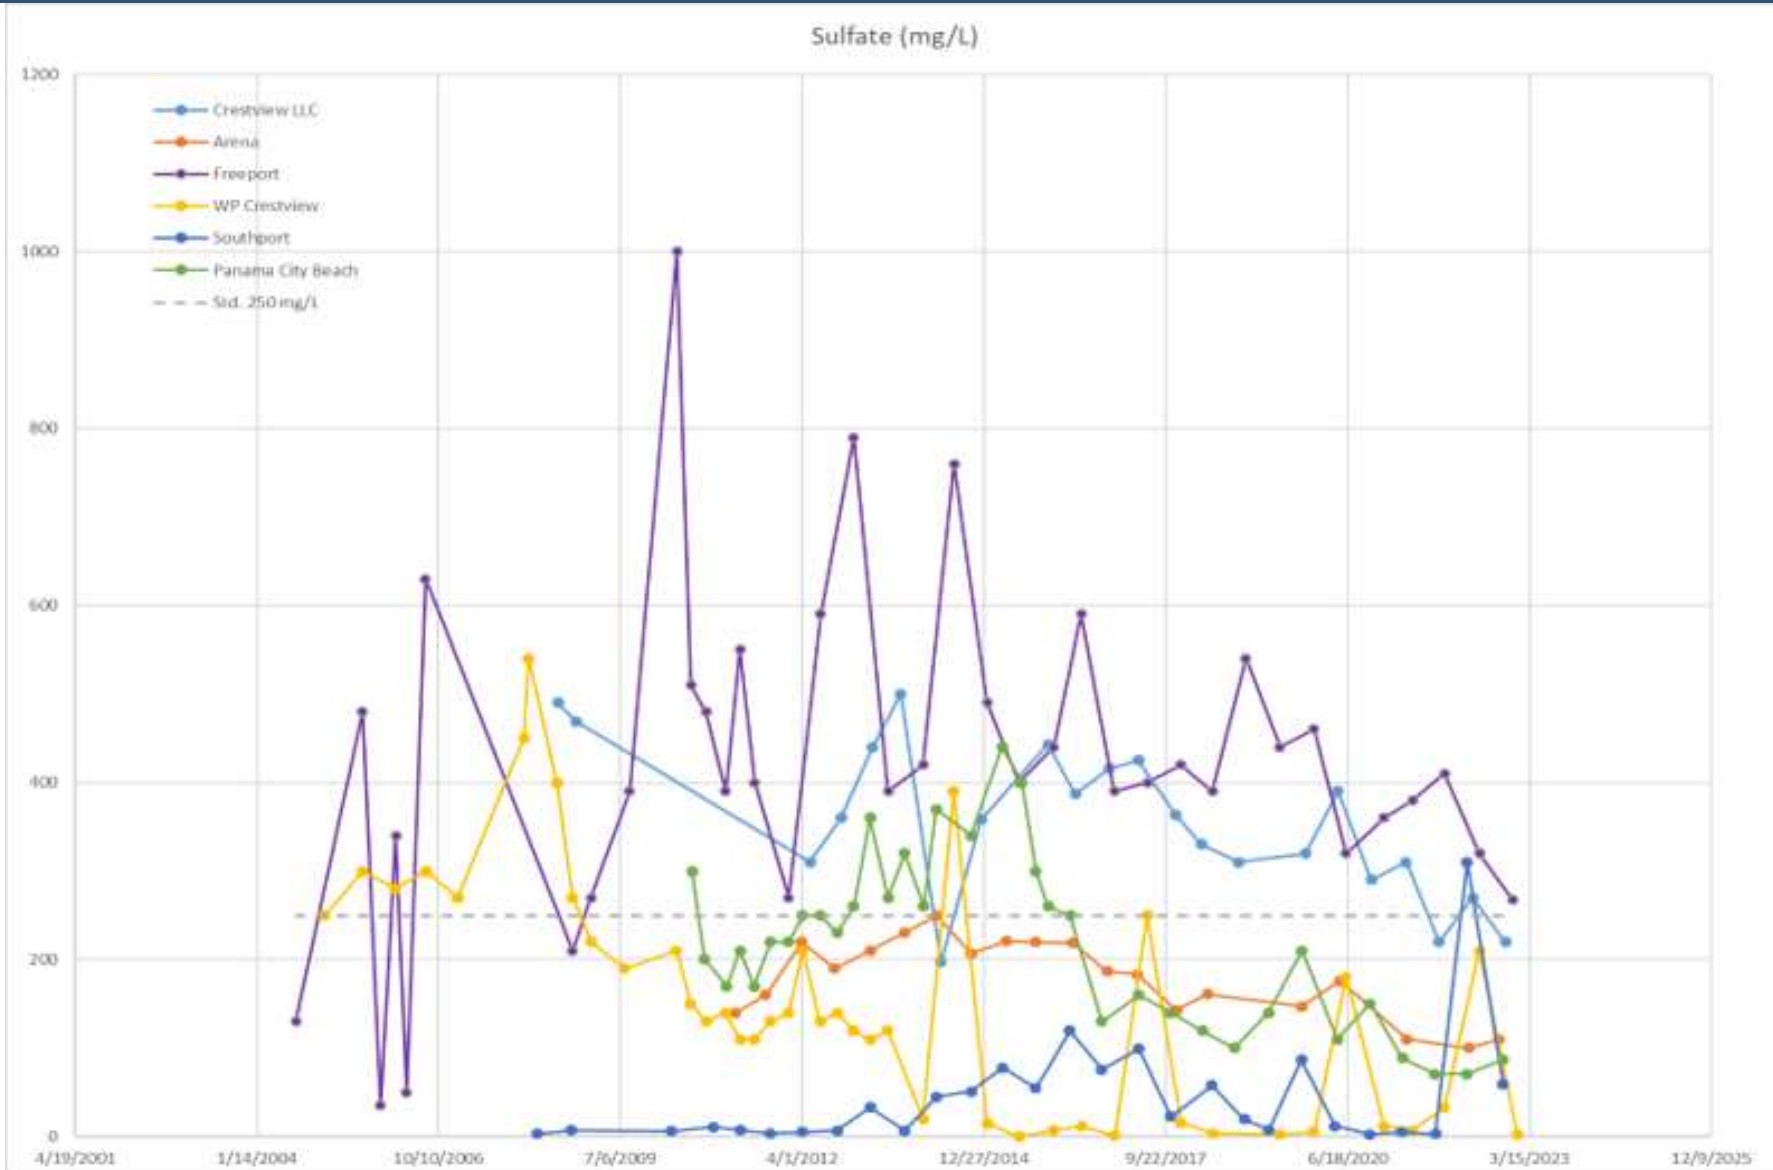
Sulfate at C&Ds

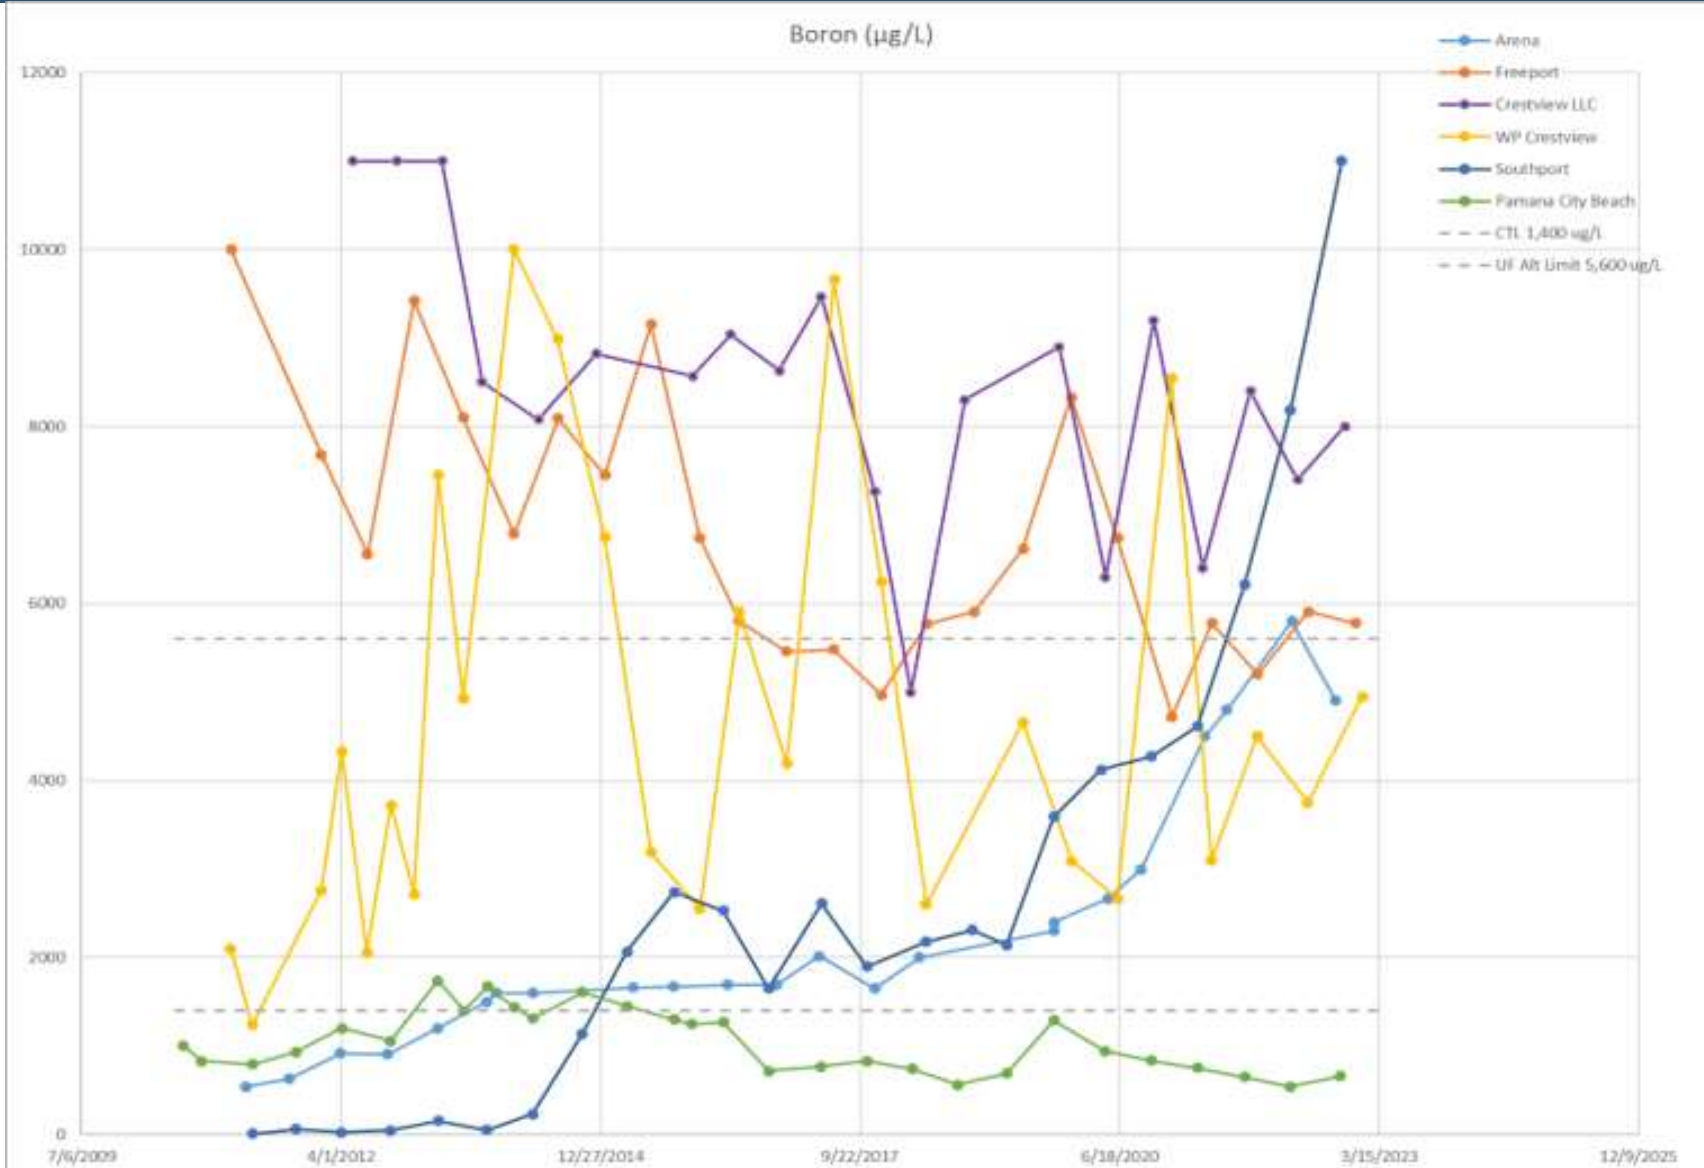
Boron at C&Ds

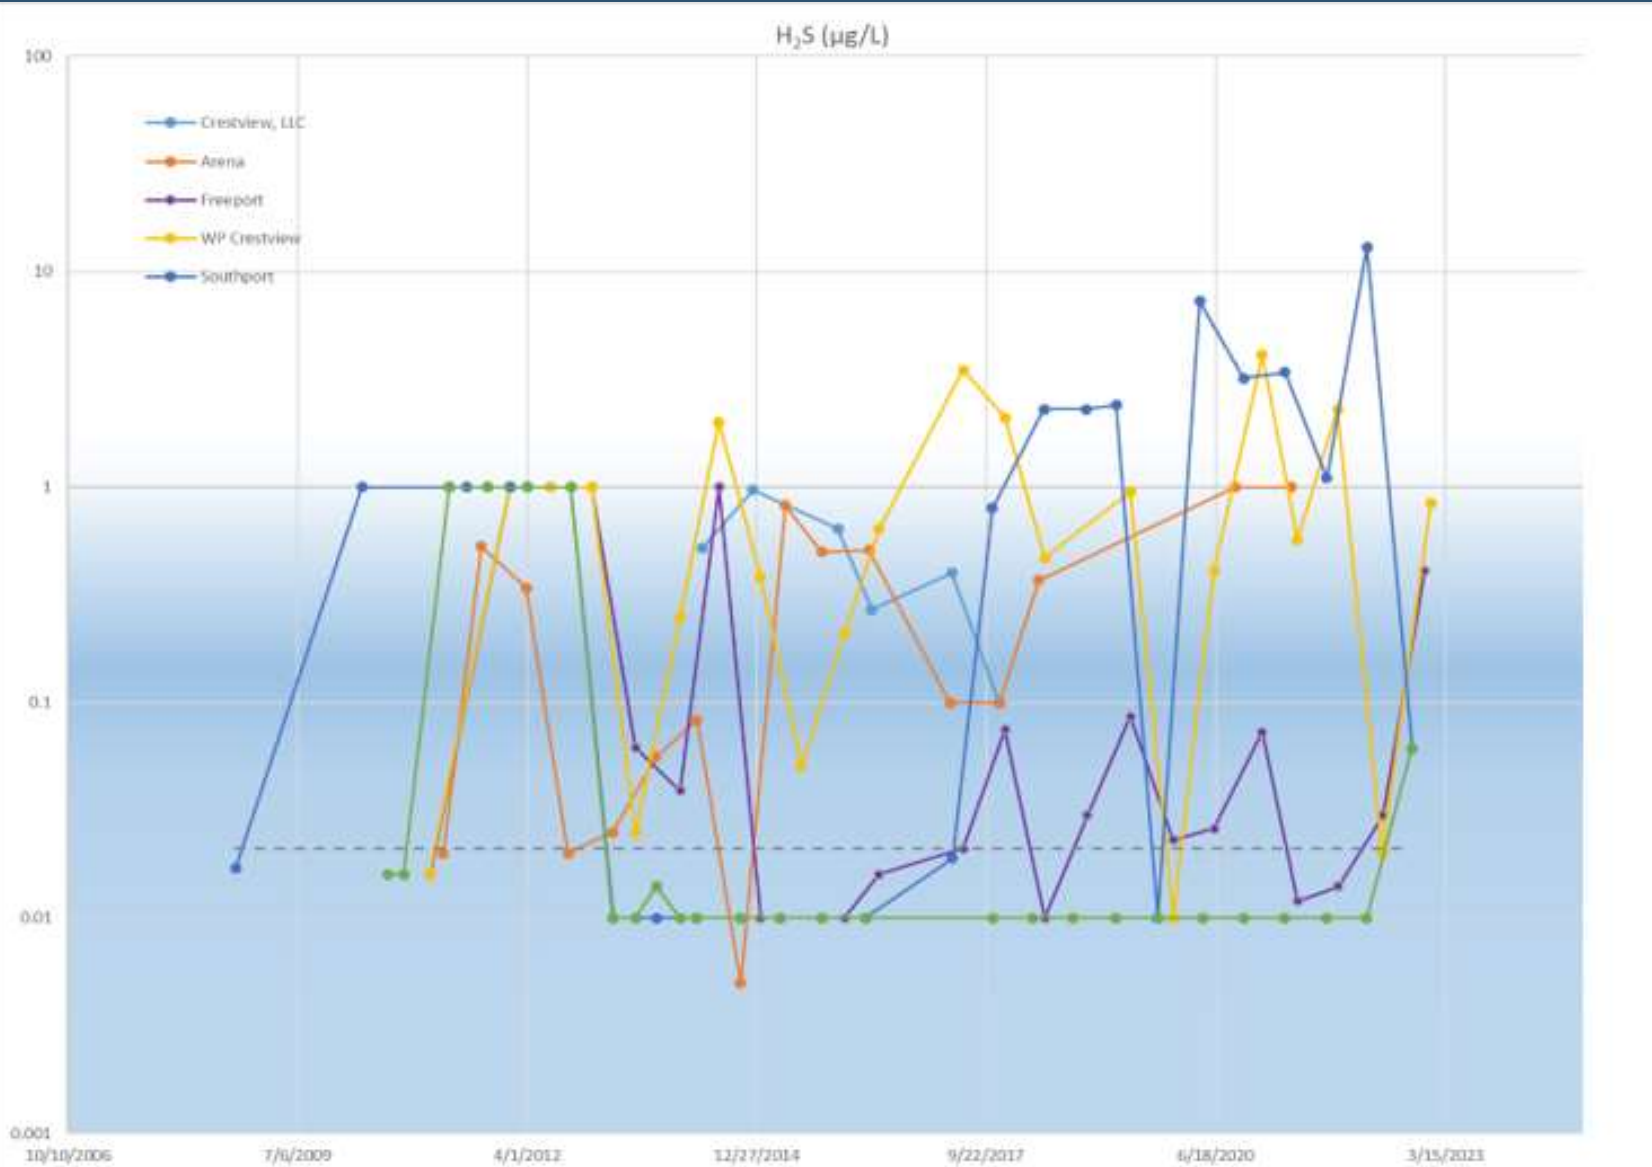
Hydrogen Sulfide at C&Ds

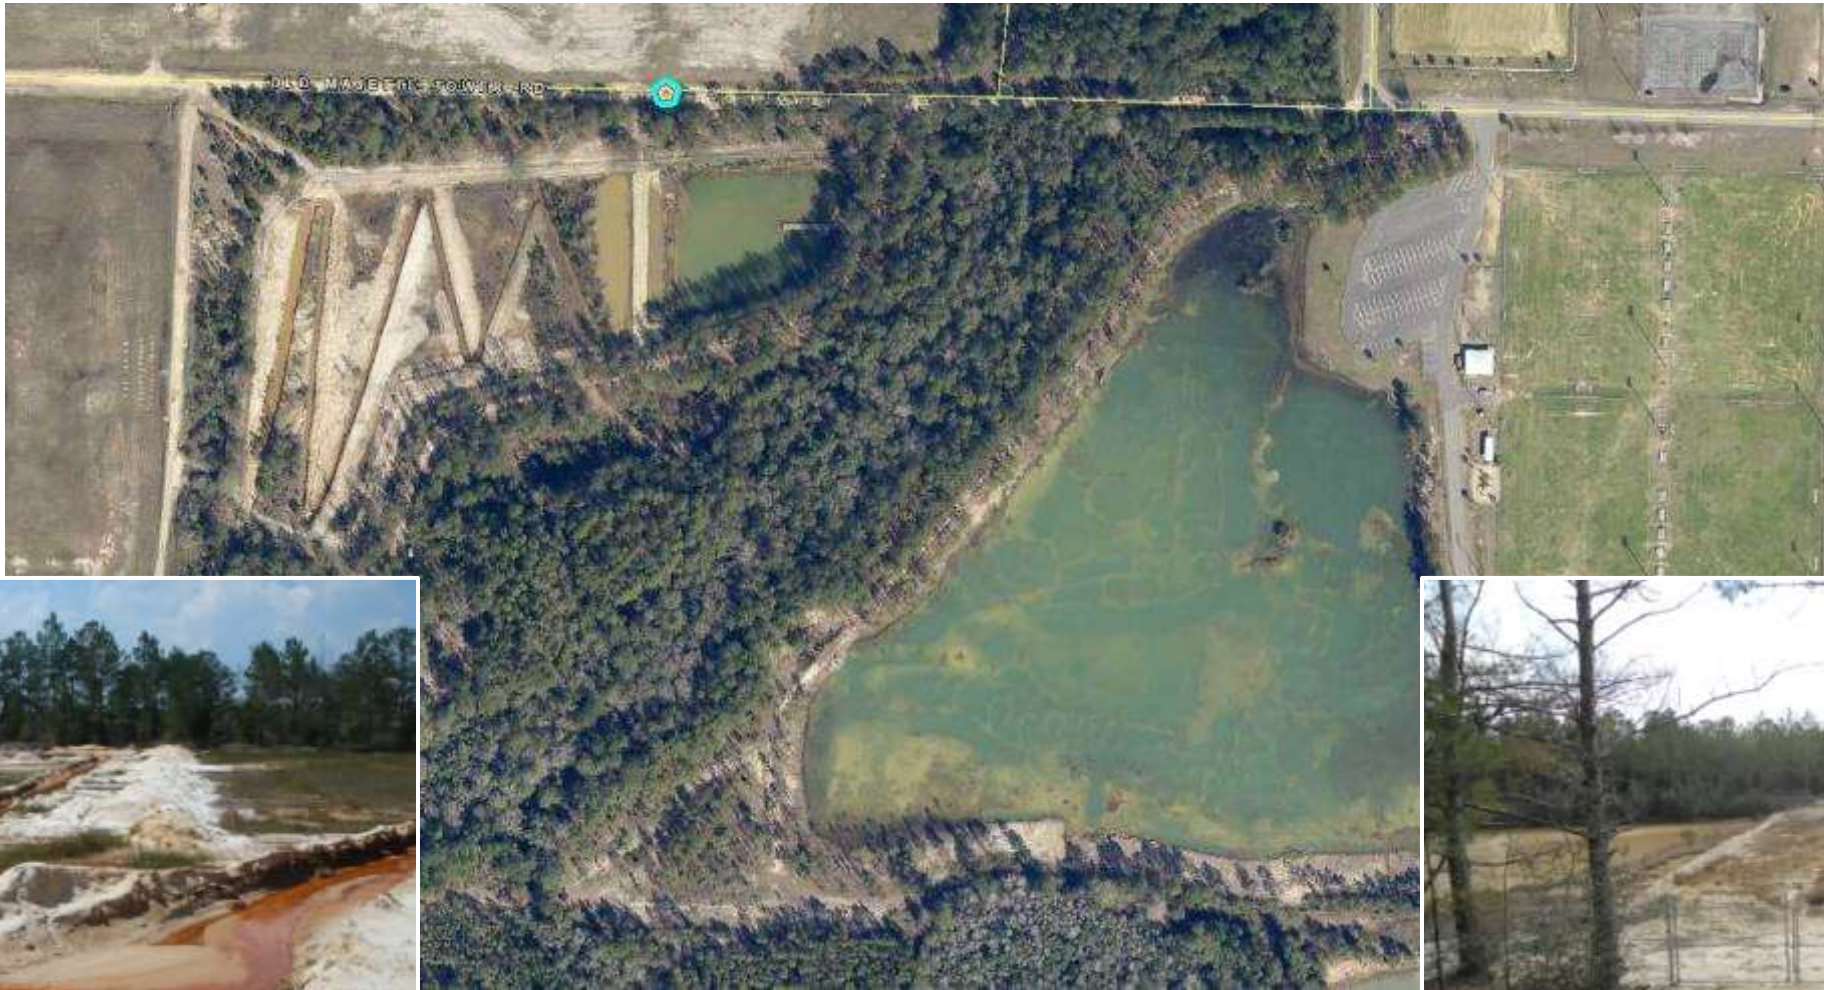
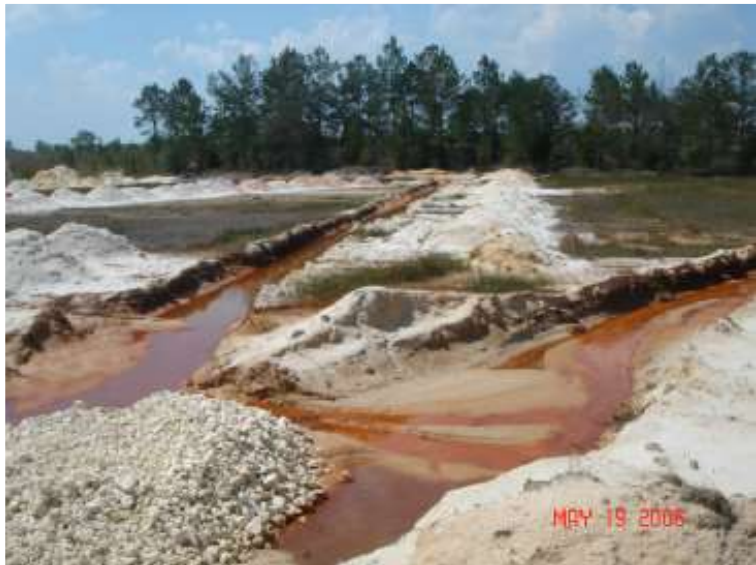
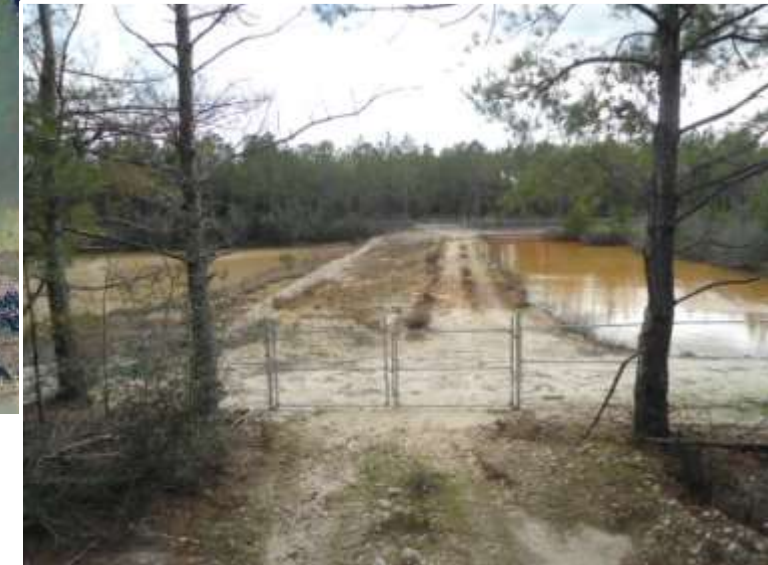
Majette Landfill Remediation System

- **Technology**
 - Pump and treat.
 - Permeable reactive barrier.
- **Systems in place (landfills)**
 - Santa Rosa County.
 - Escambia County.
 - Okaloosa County.
 - Walton County.
 - Washington County.
 - Bay County.

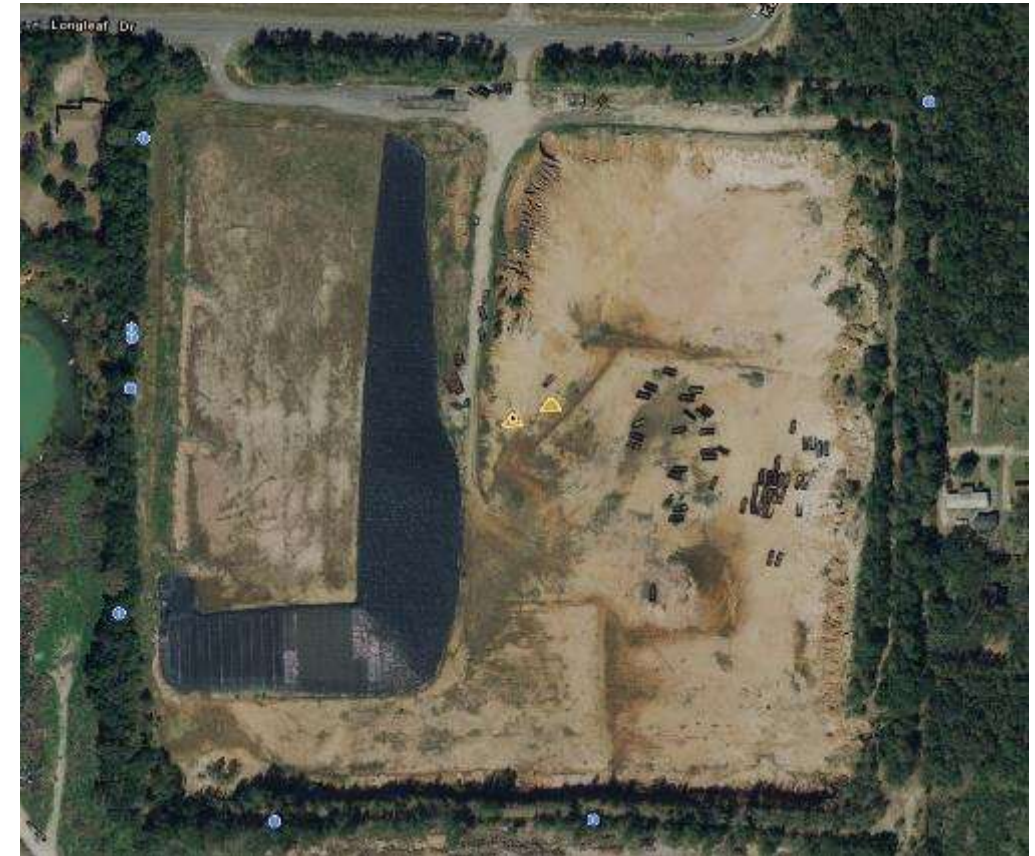
Site Layout

- Longleaf C&D in Escambia County, Florida.
- First permitted in 2006.
- Groundwater contamination noted.
- Pilot study approved to install impermeable cap as part of remedial action plan.
- Cap installation completed February 2014.
- Currently under a monitoring only plan.
- Future cells will be lined.

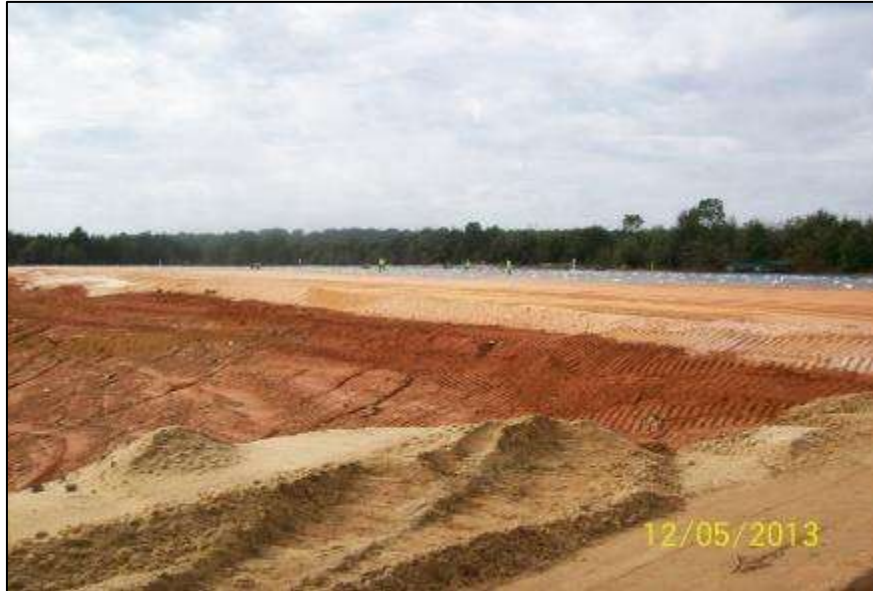
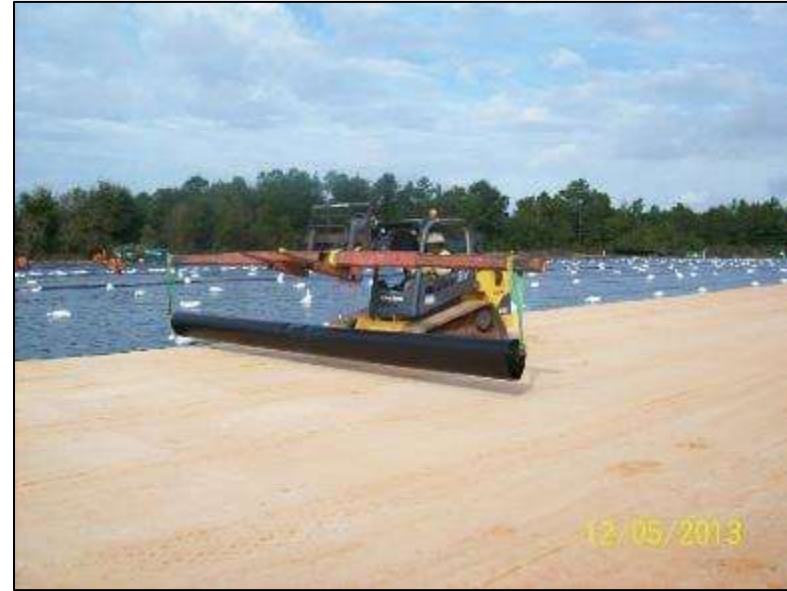
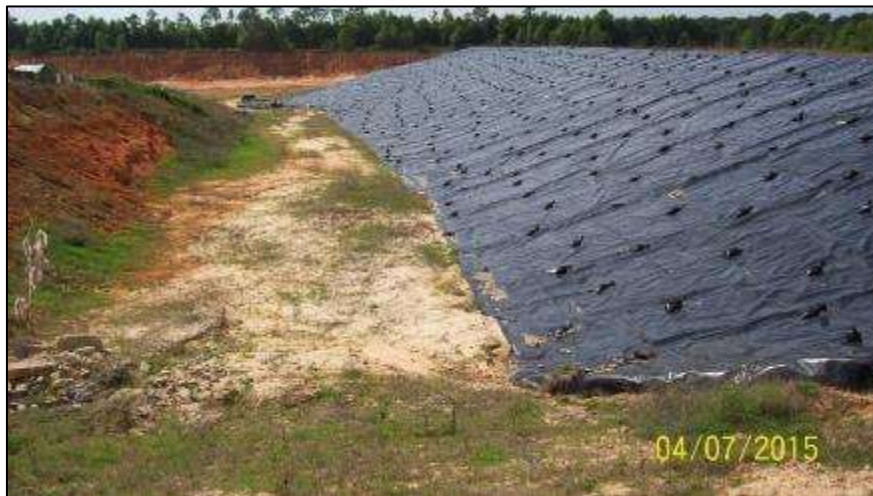
Cap Placement
