Unlined Construction and Demolition Debris Disposal Facilities

Dawn Templin, P.E.
Alex Webster, P.G.
Northwest District

Florida Department of Environmental Protection

Pensacola, FL | June 16, 2023

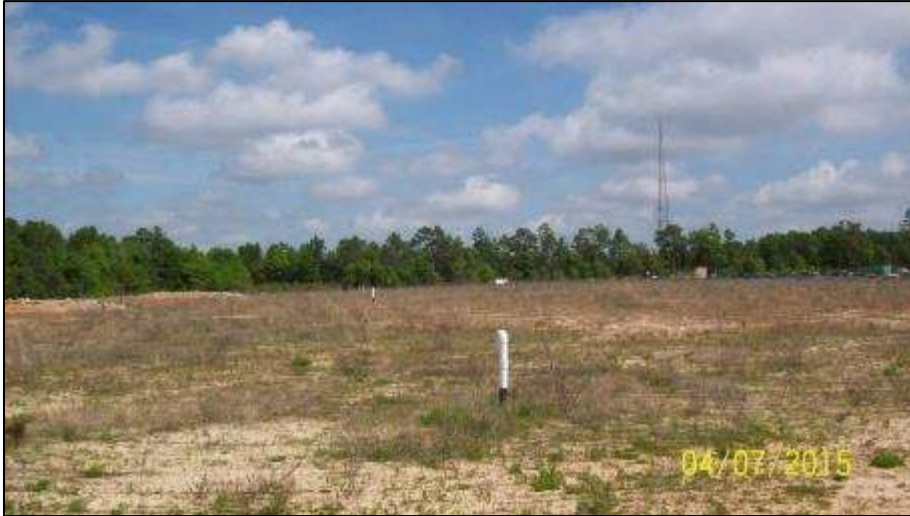
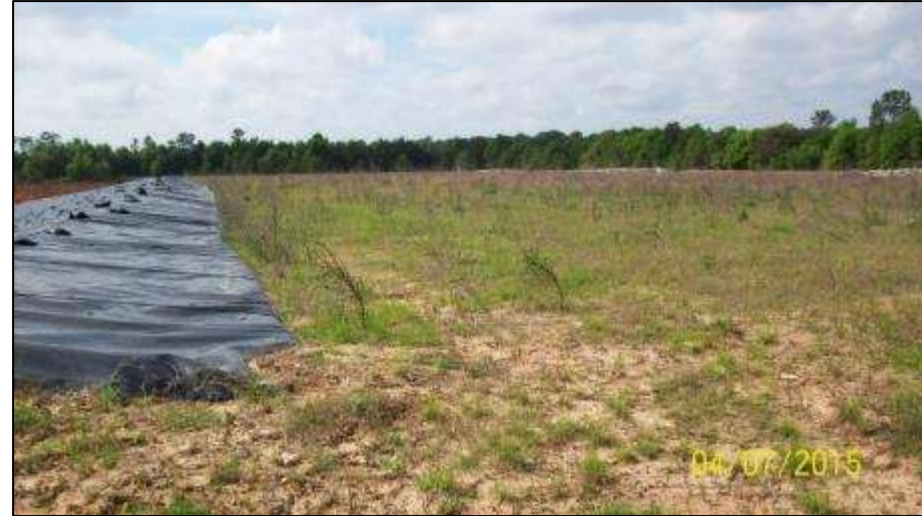
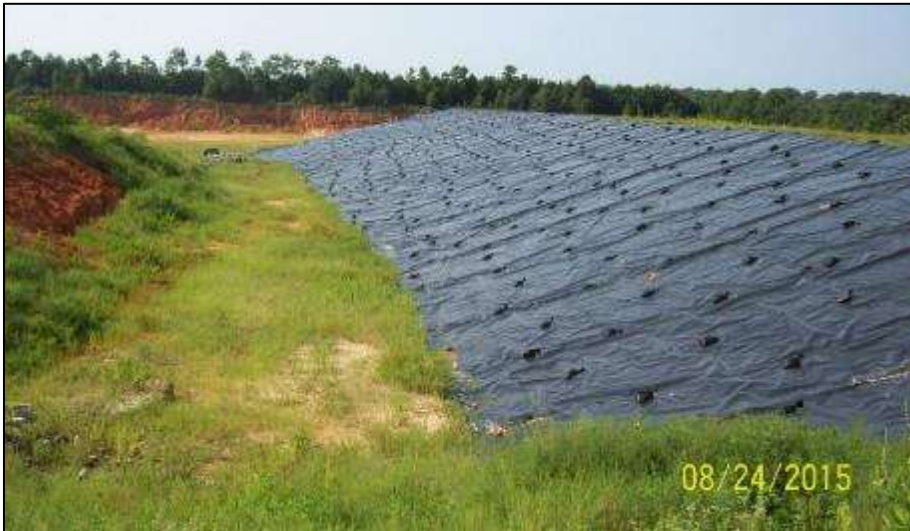
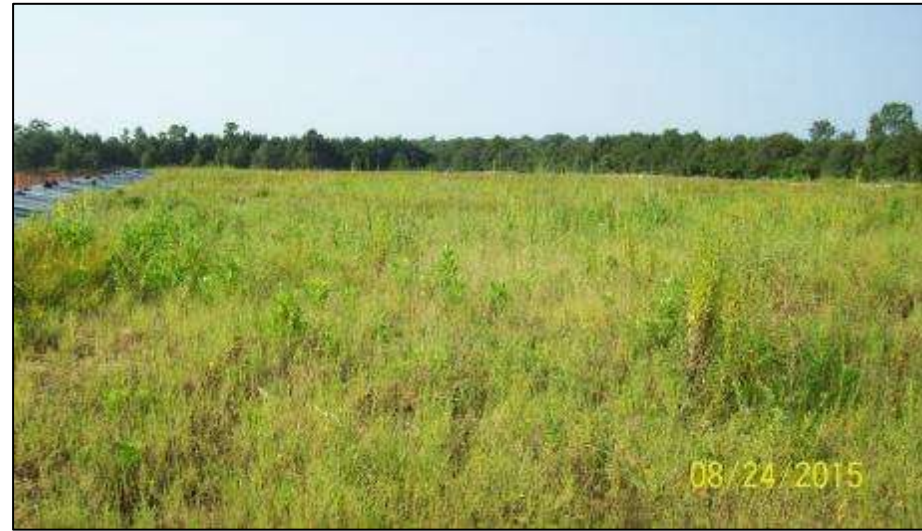
Completed Cap

- Longleaf C&D in Escambia County, Florida.
- First permitted in 2006.
- Groundwater contamination noted.
- Pilot study approved to install impermeable cap as part of remedial action plan.
- Cap installation completed February 2014.
- Currently under a monitoring only plan.
- Future cells will be lined.

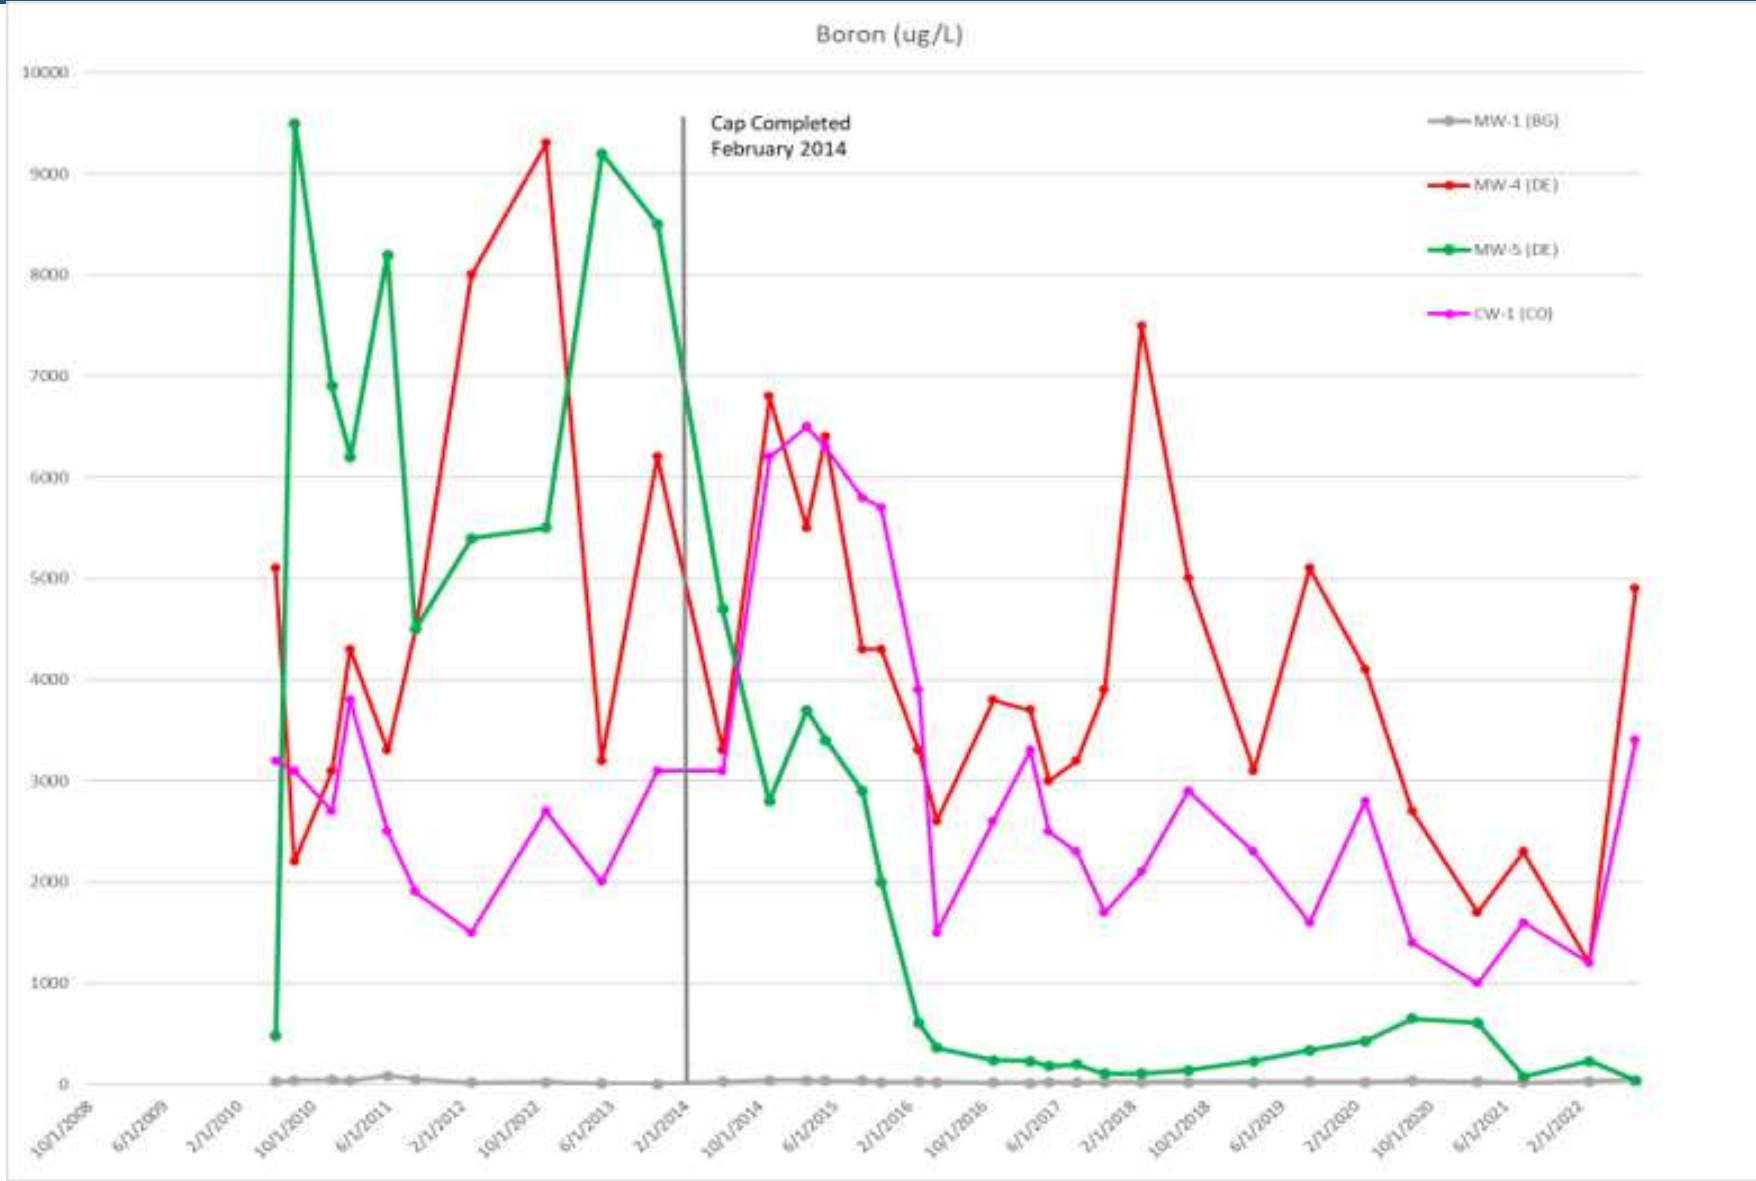
Impermeable Caps for Unlined C&Ds: Boron

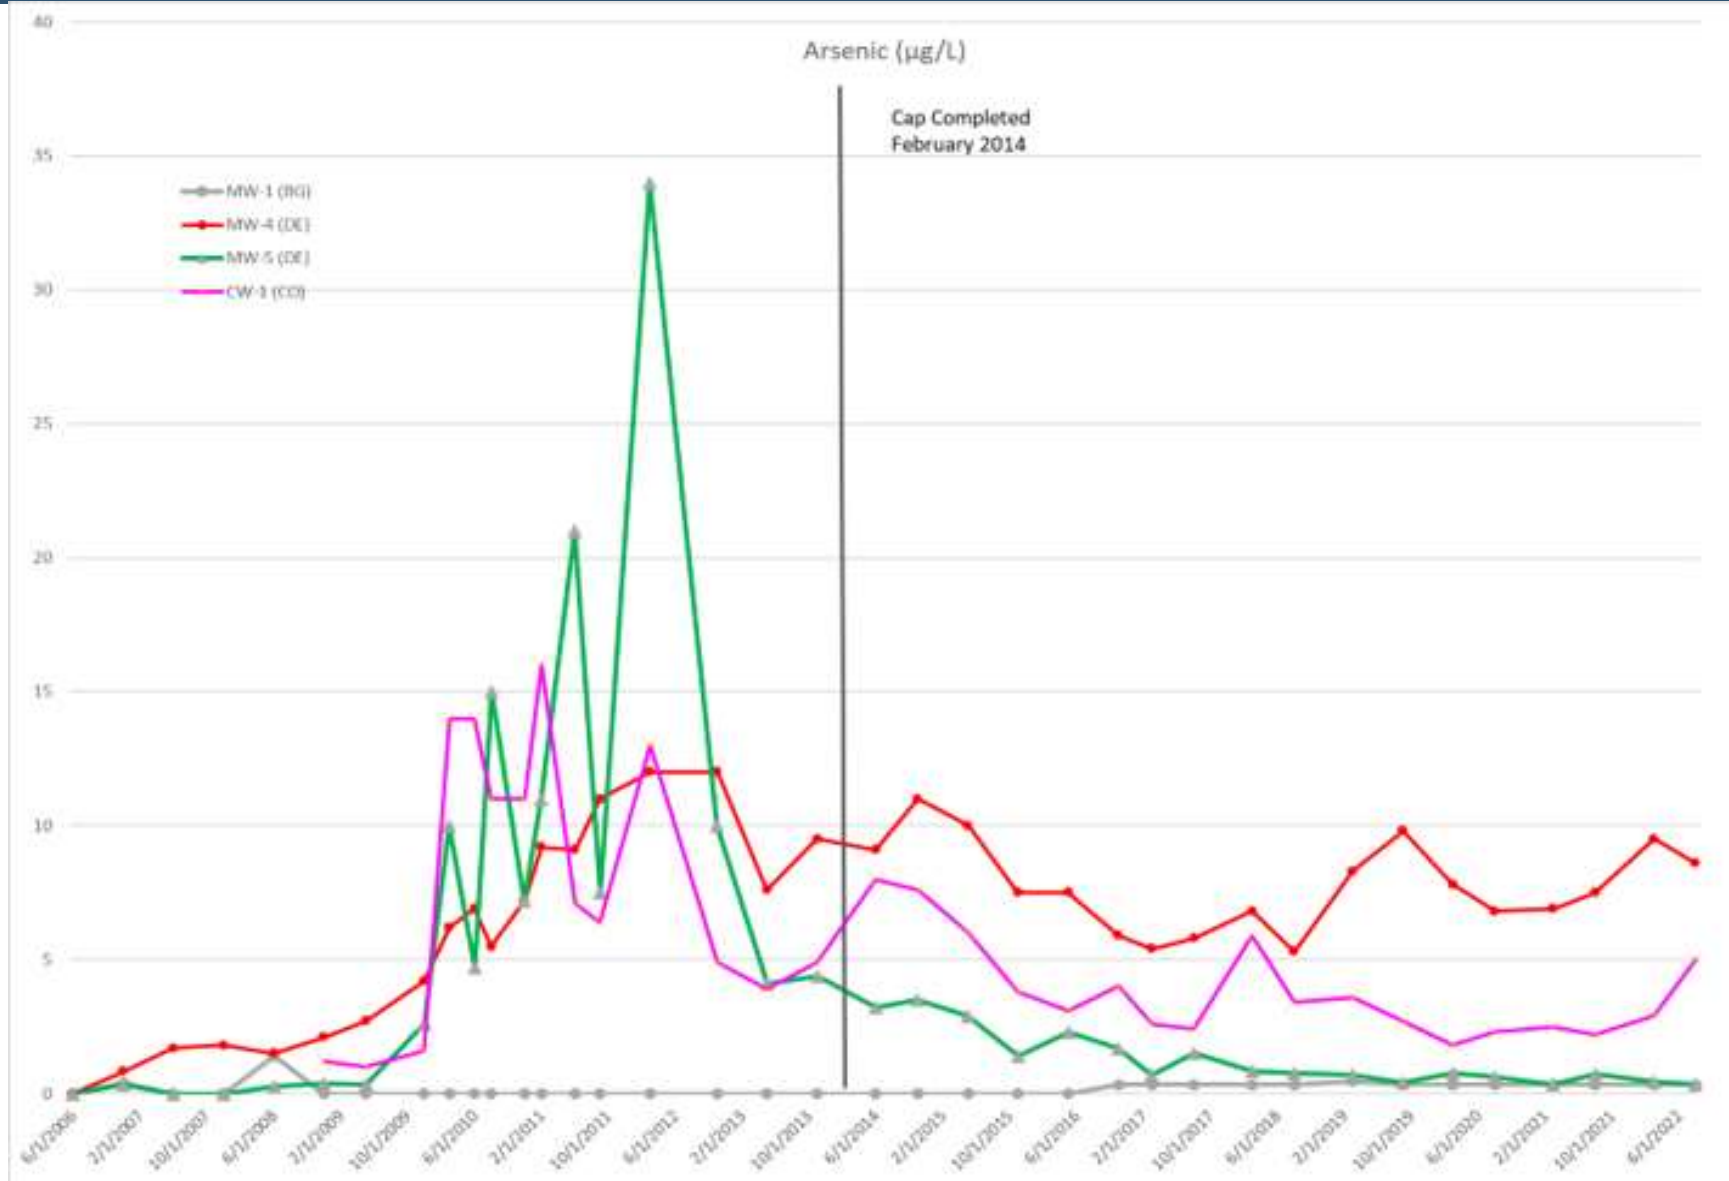
Impermeable Caps for Unlined C&Ds: Arsenic

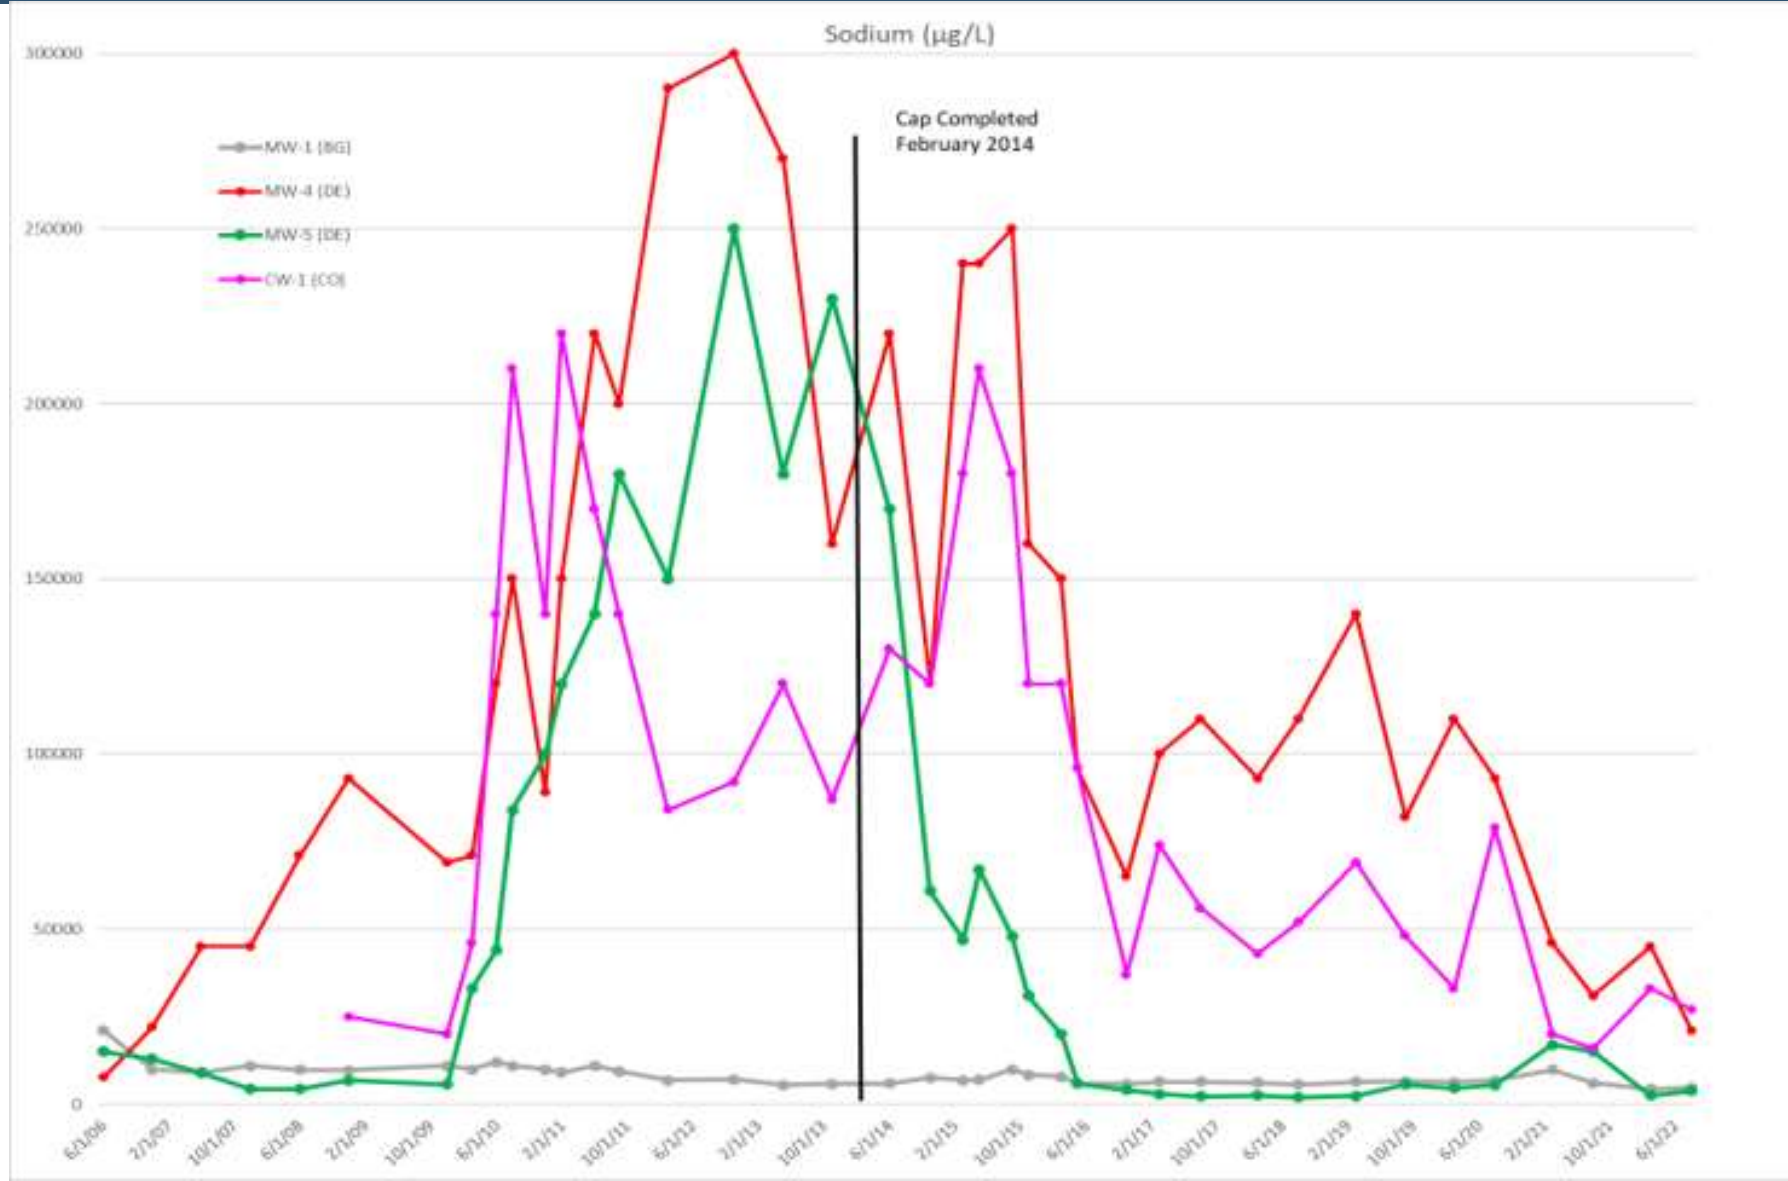
Impermeable Caps for Unlined C&Ds: Sodium

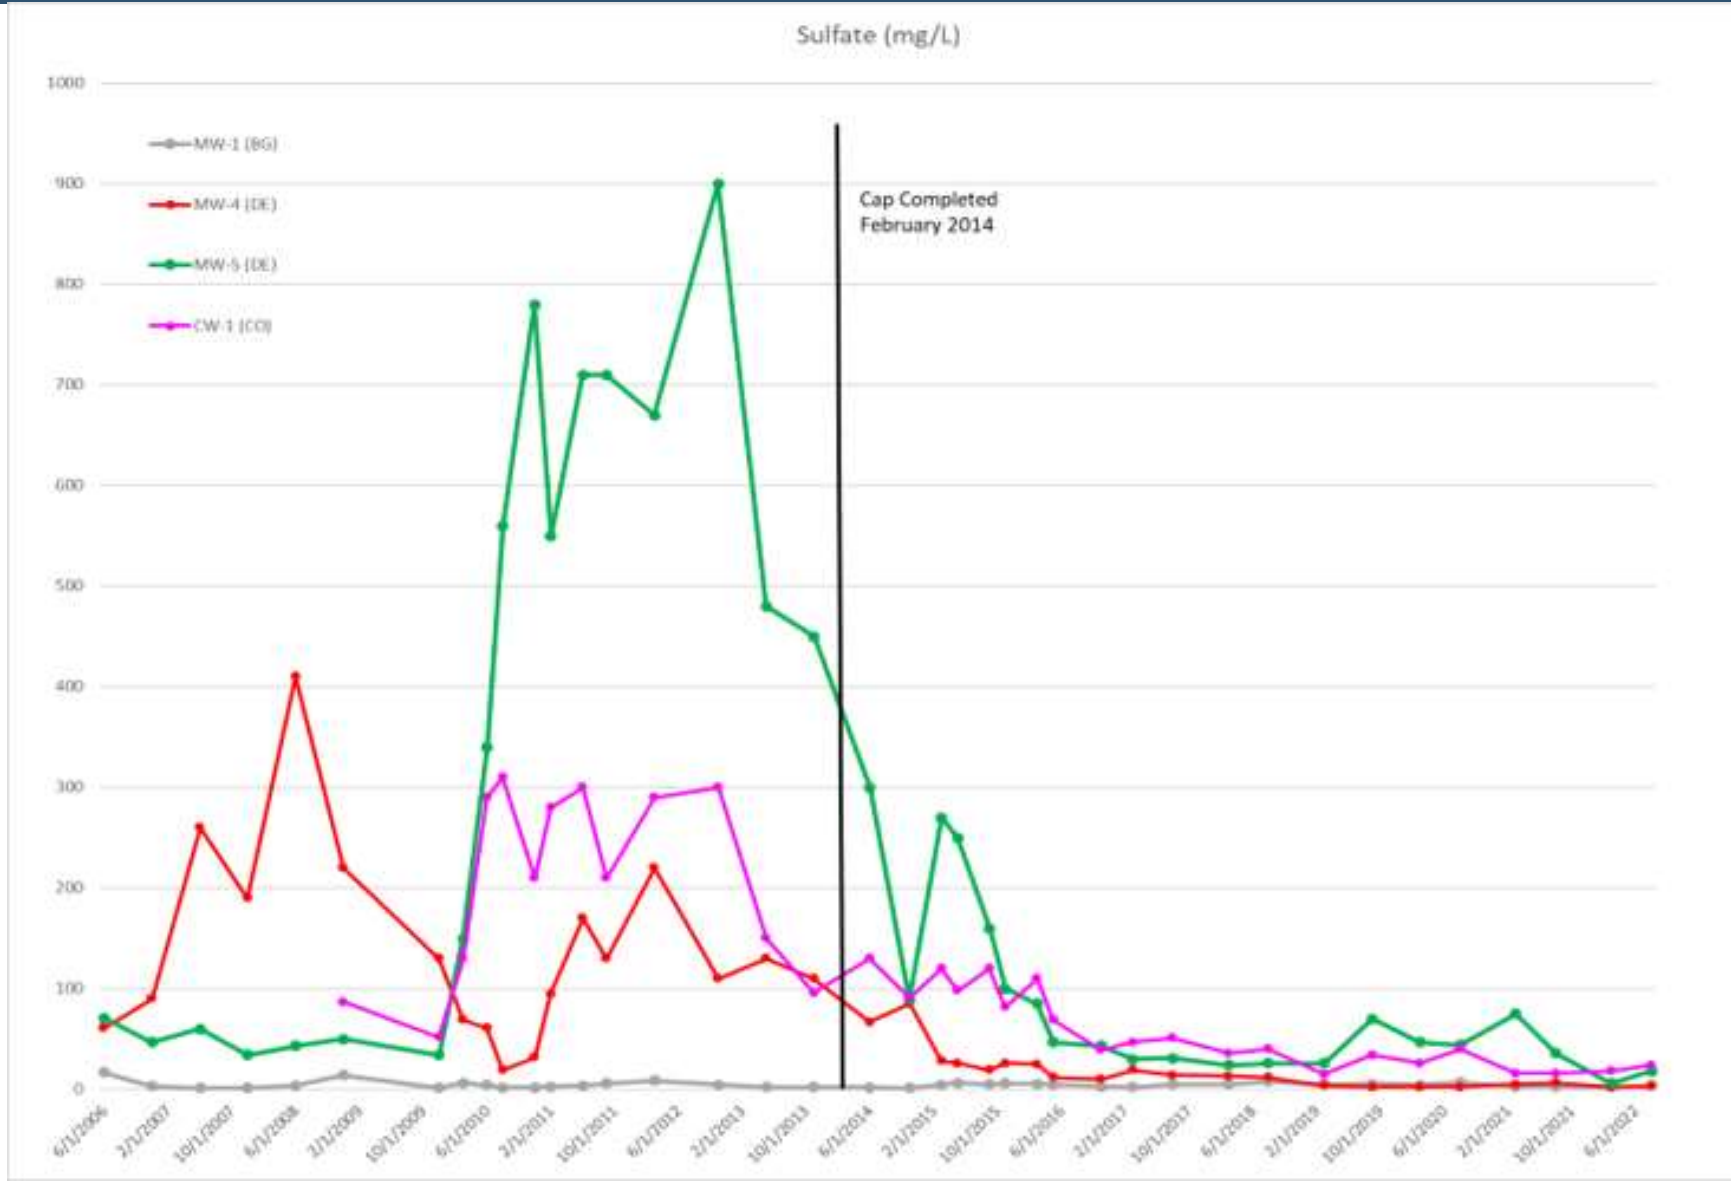
Impermeable Caps for Unlined C&Ds: Sulfate

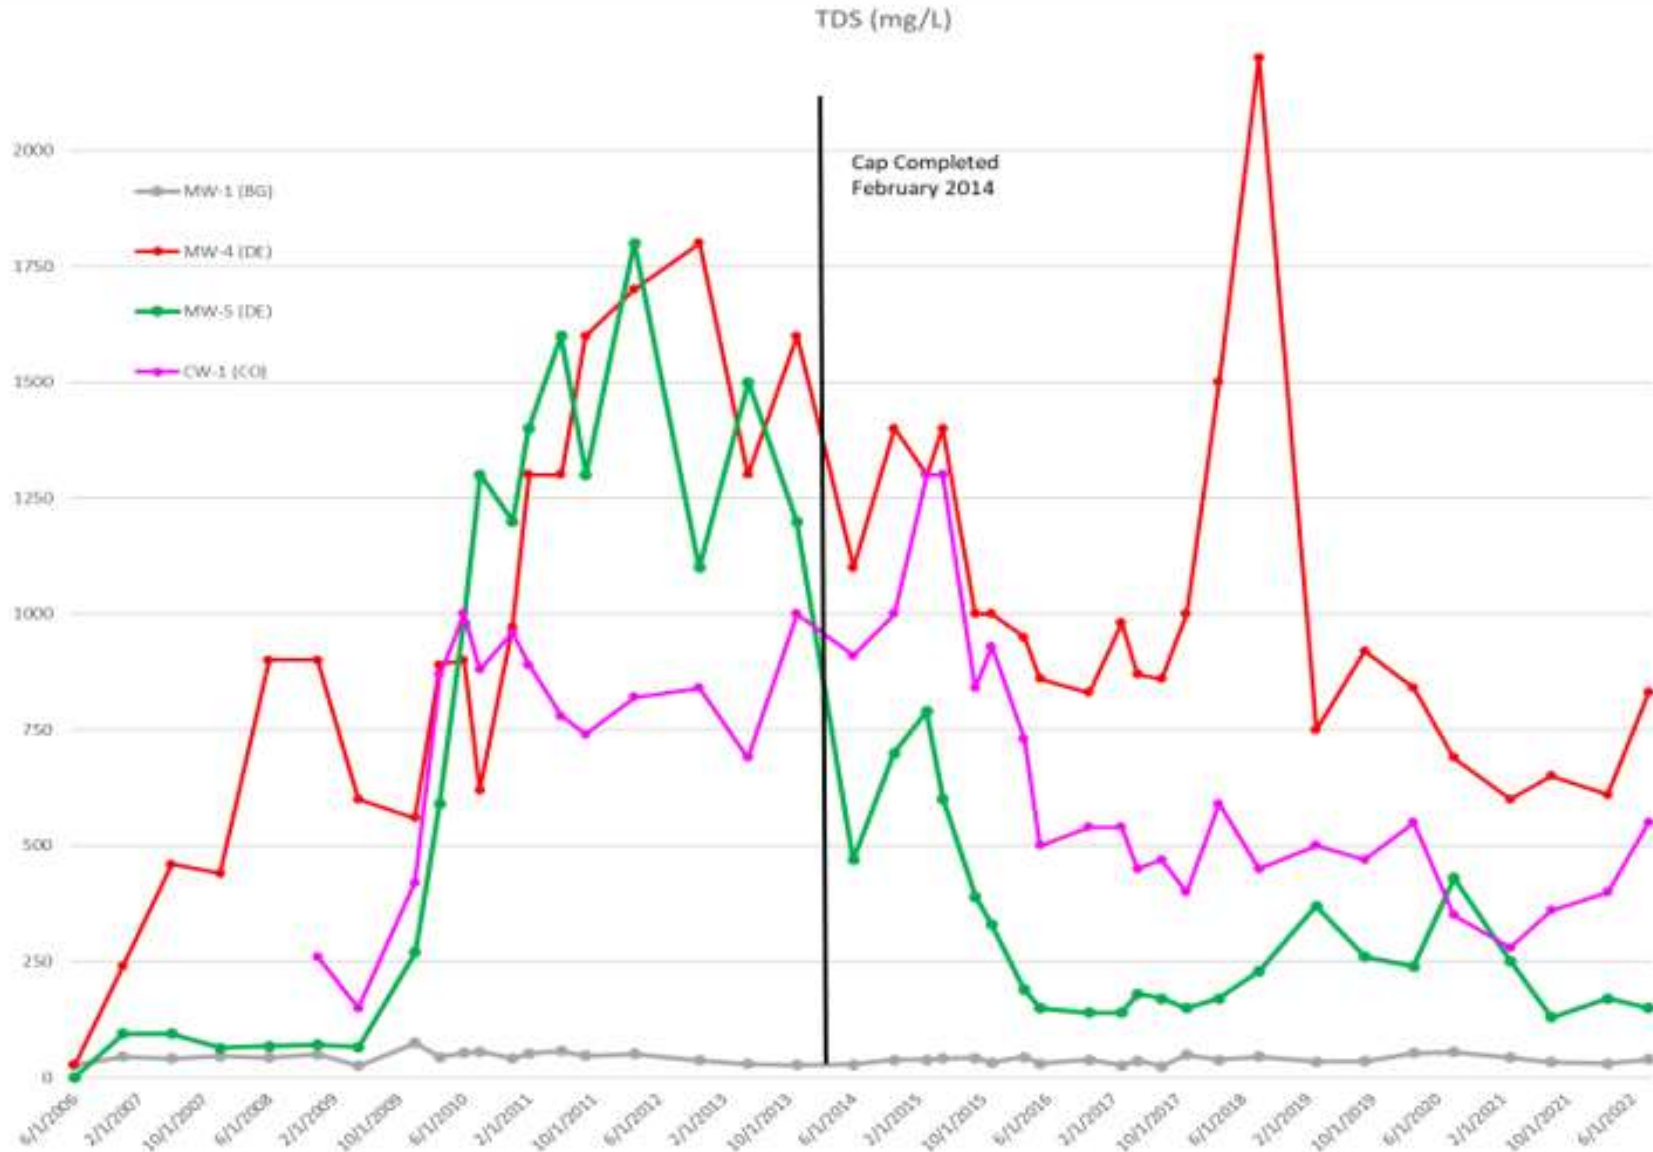
Impermeable Caps for Unlined C&Ds: TDS

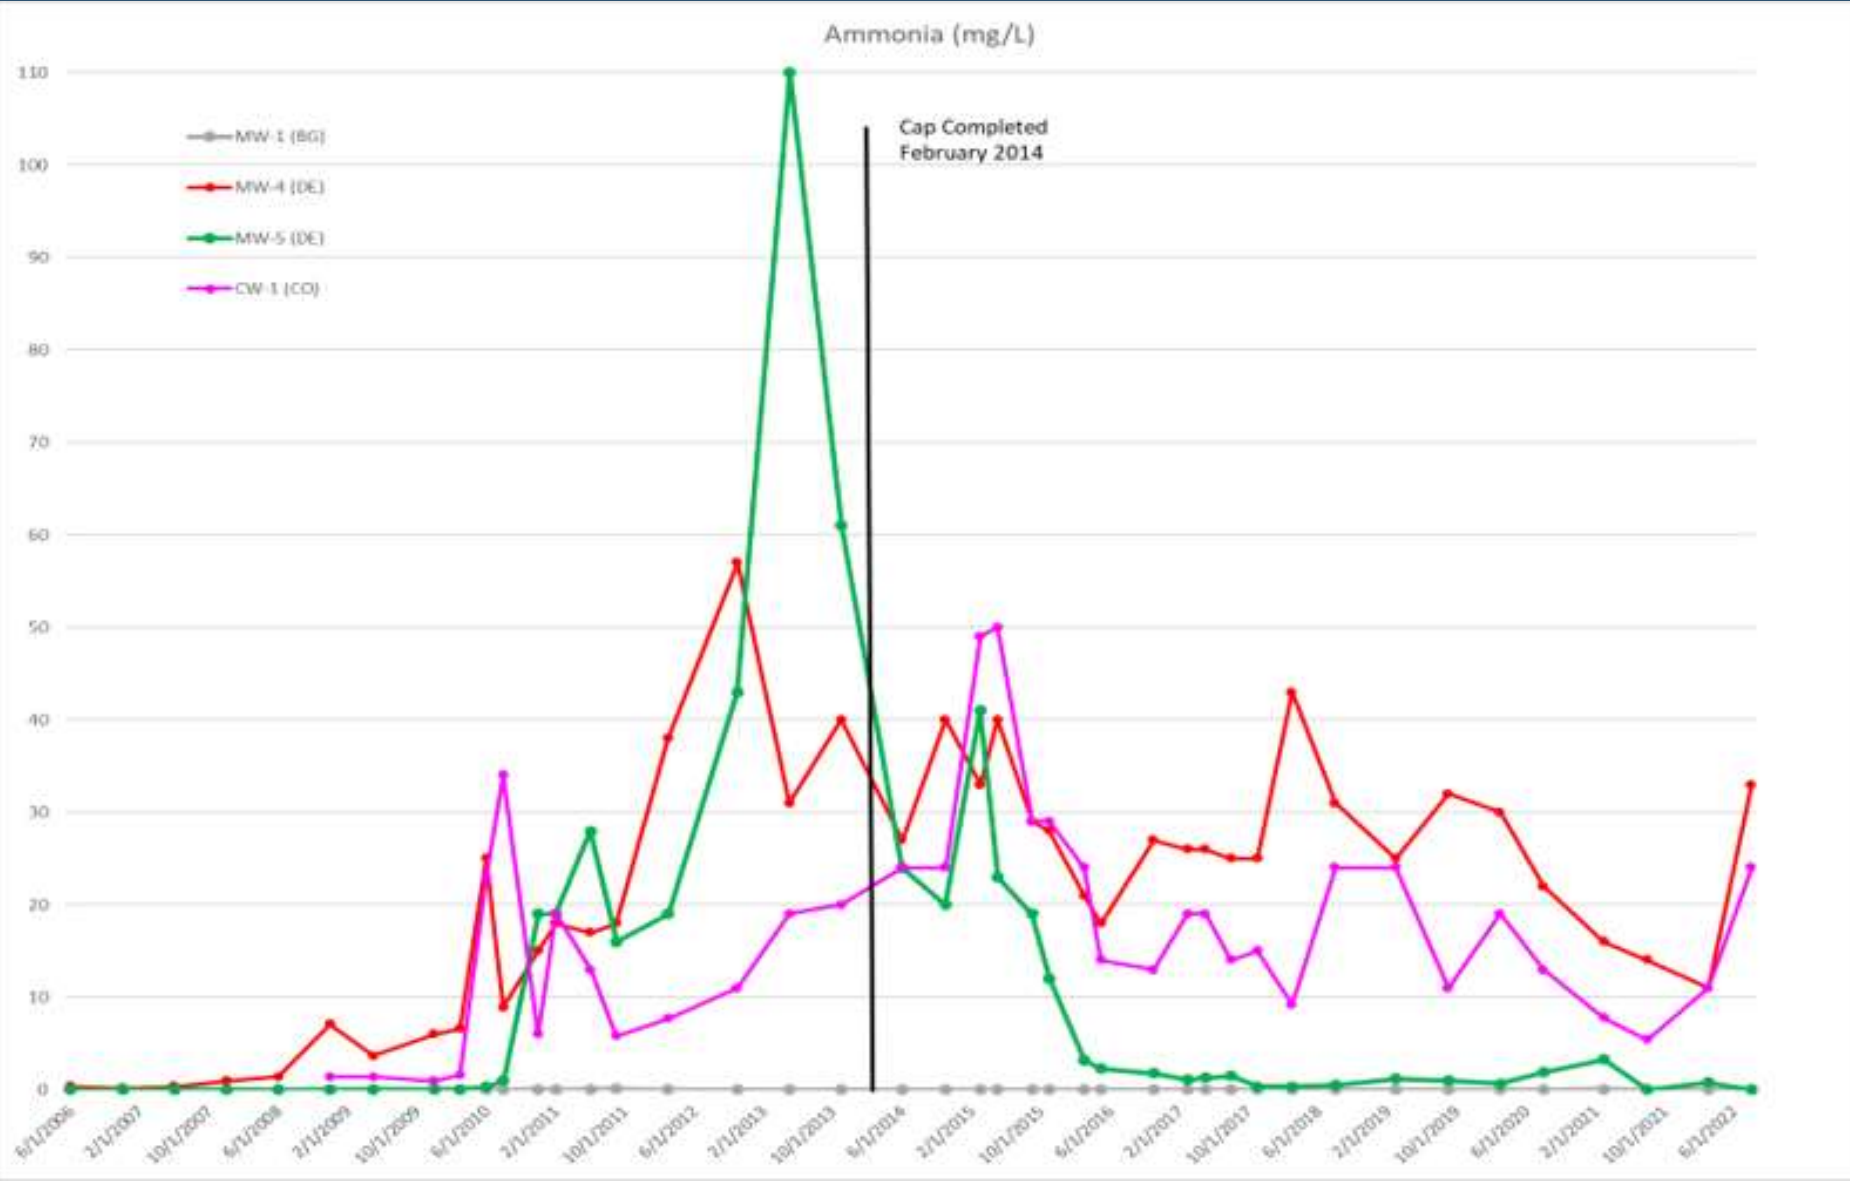
Impermeable Caps for Unlined C&Ds: Ammonia

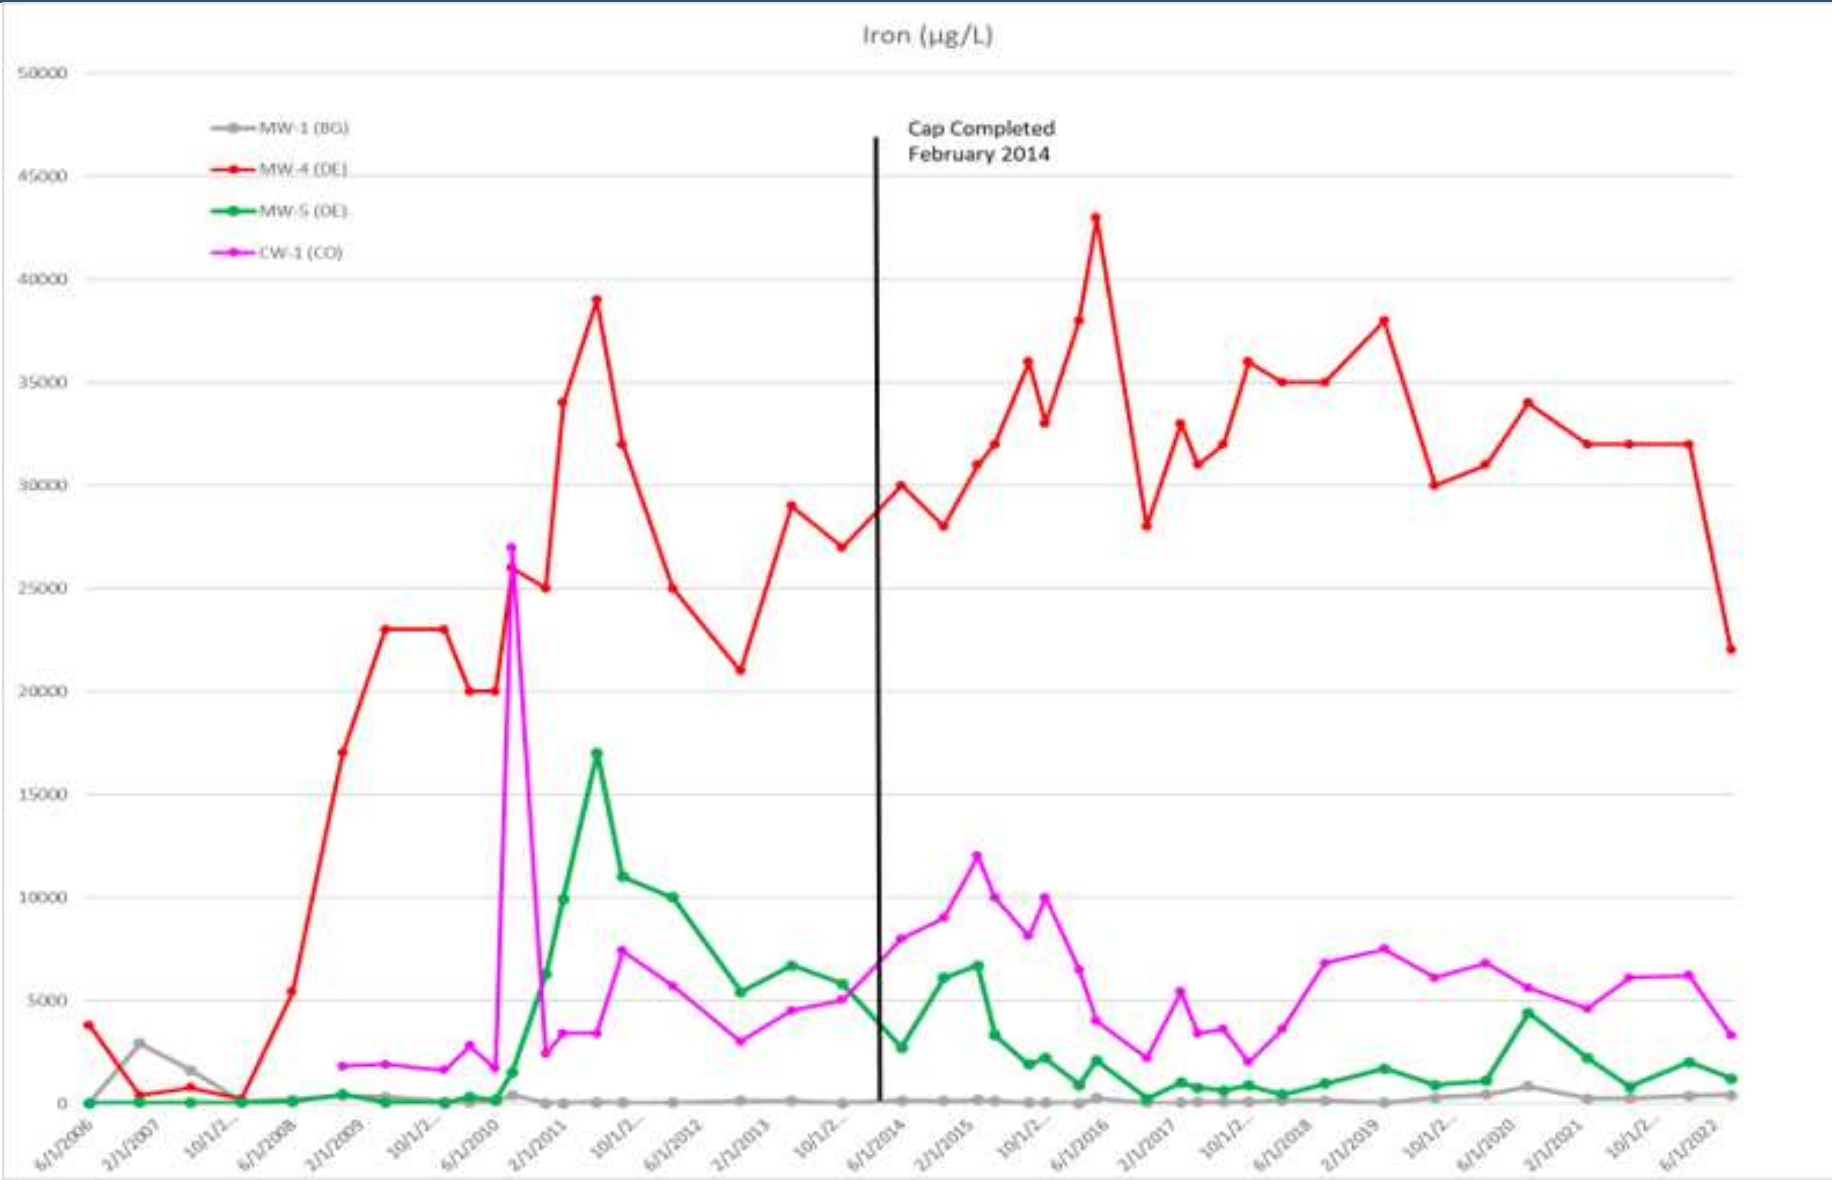
Impermeable Caps for Unlined C&Ds: Iron

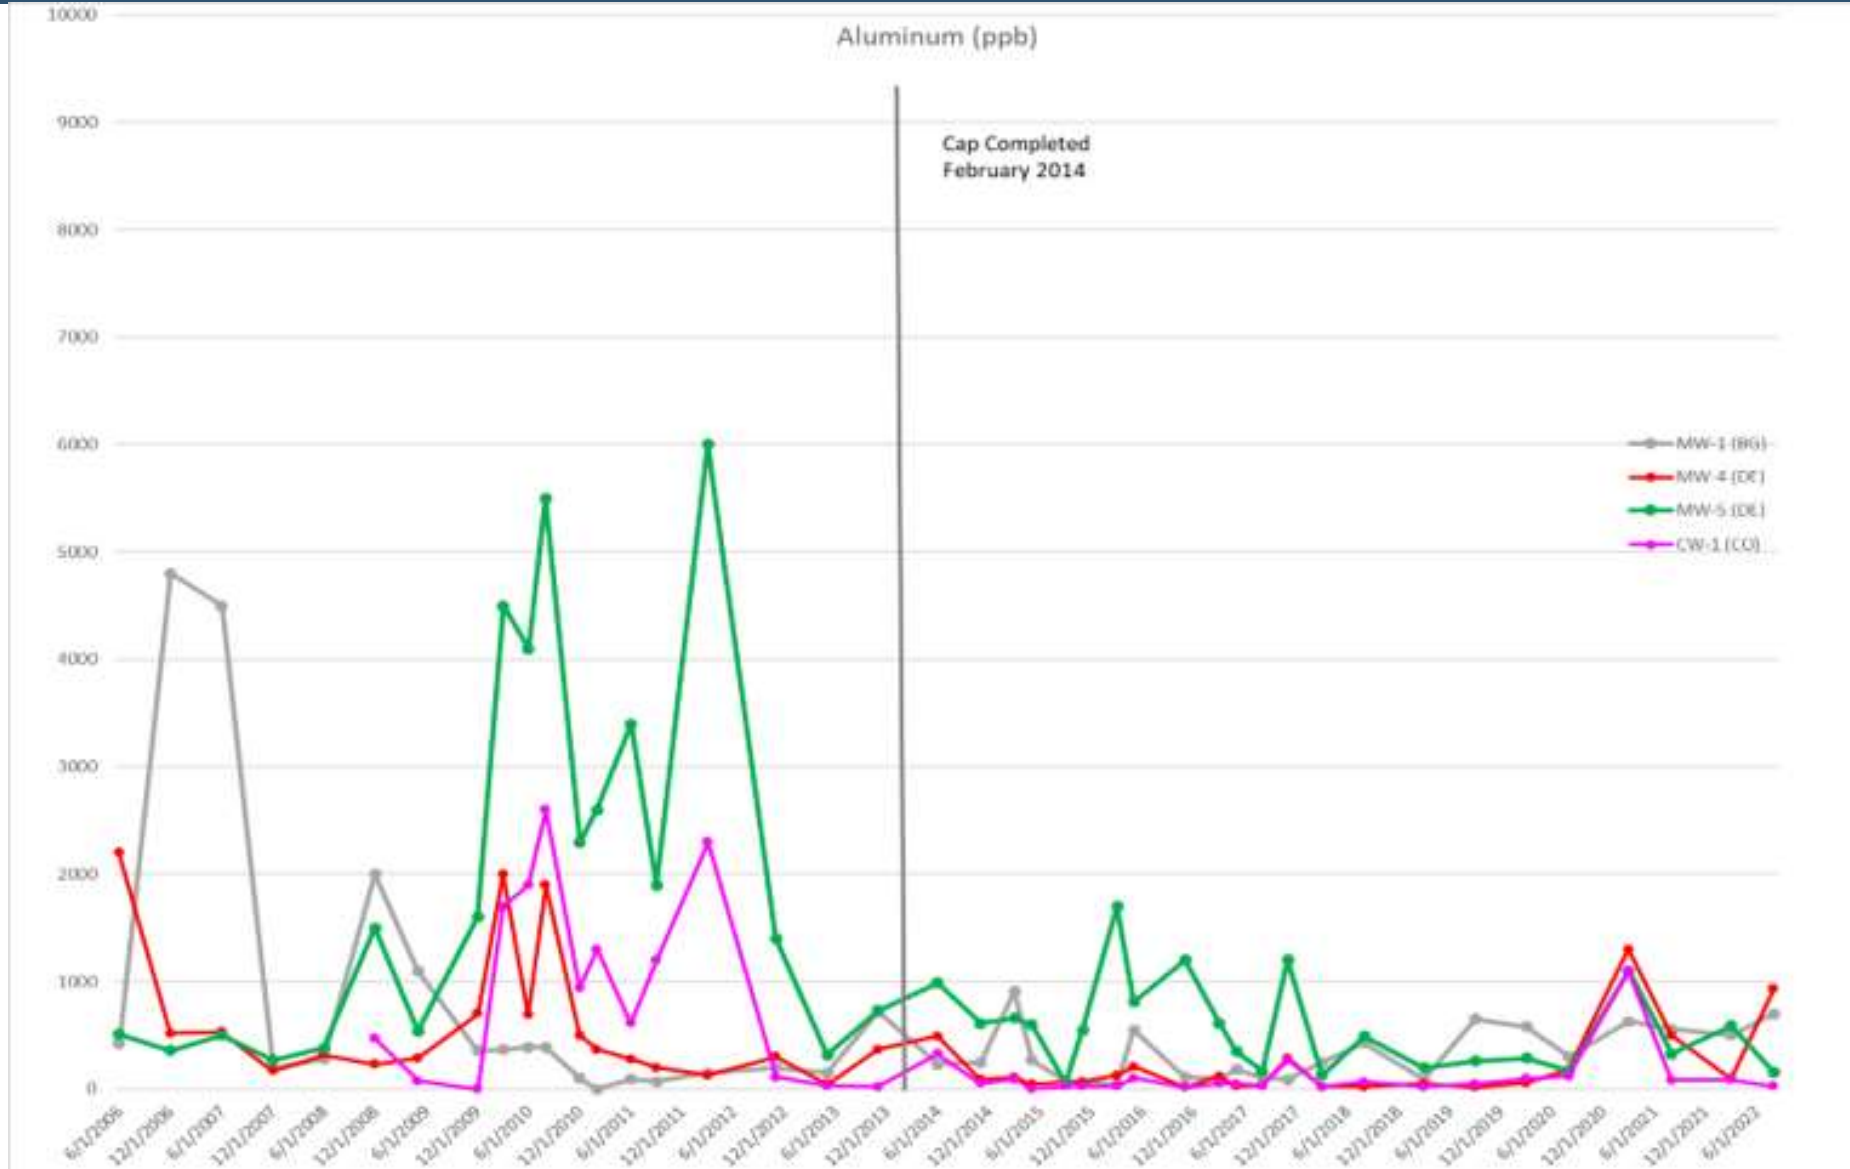
Impermeable Caps for Unlined C&Ds: Aluminum

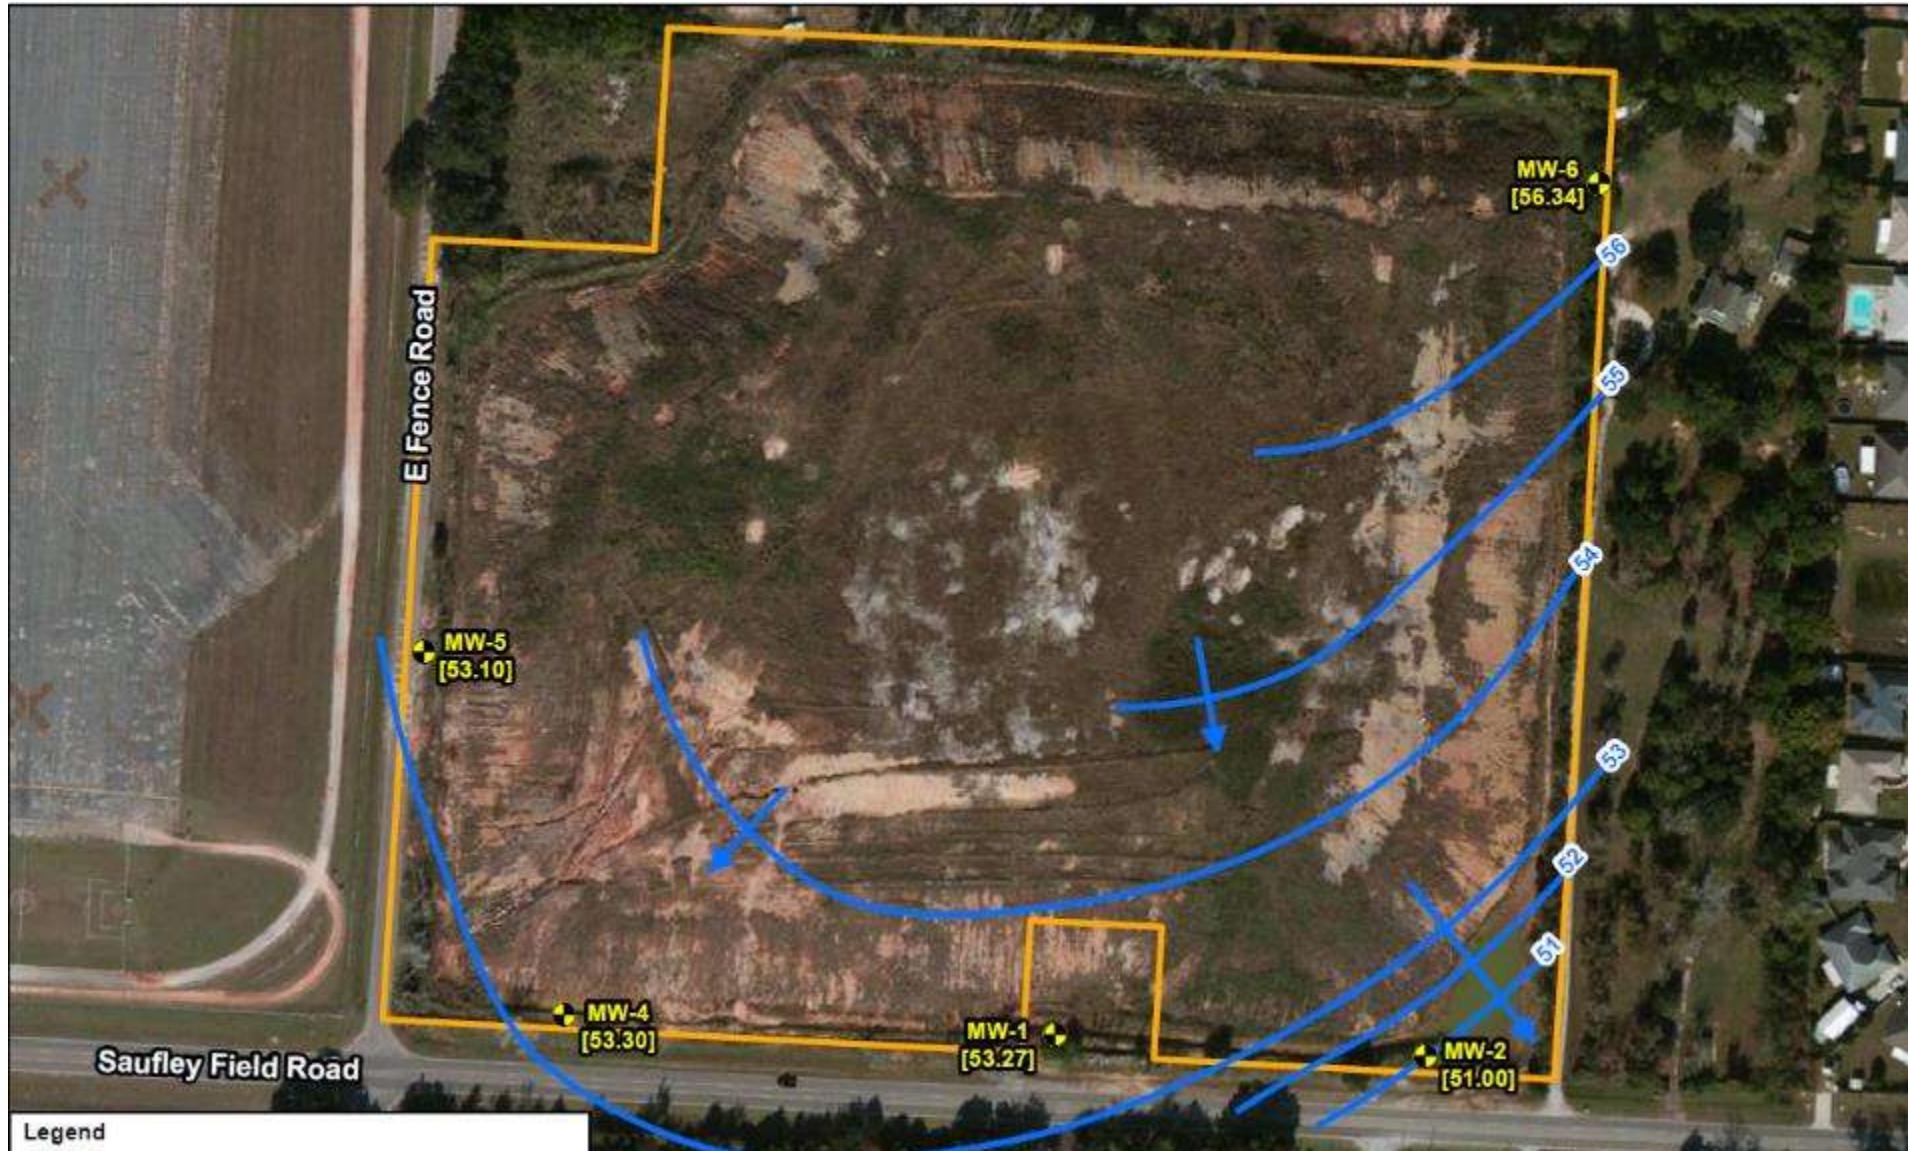
Site Layout

- General permit issued in 1990.
- Multiple enforcement actions taken 1990 – 2008.
- Fires 2000, 2002, 2005 and 2006.
- Lawsuit filed 2006.
- Air quality study issued February 2007 (H₂S).
- Height above permitted dimensions.
- Ordered to close in 2008 – site was abandoned.
- Escambia County entered into an agreement with DEP to close the facility.
- Decided to close with synthetic cap.
 - Alternate procedure requested and approved by division.
- Closure activities 2012 - 2013.
 - Included waste removal to bring height down.
- Over \$5 million to close site.
 - Cost estimate \$344,817.
- Monitoring (post LTC) being conducted by county.
- State-funded cleanup list.
