Unlined Construction and Demolition Debris Disposal Facilities

Dawn Templin, P.E.
Alex Webster, P.G.
Northwest District

Florida Department of Environmental Protection

Pensacola, FL | June 16, 2023

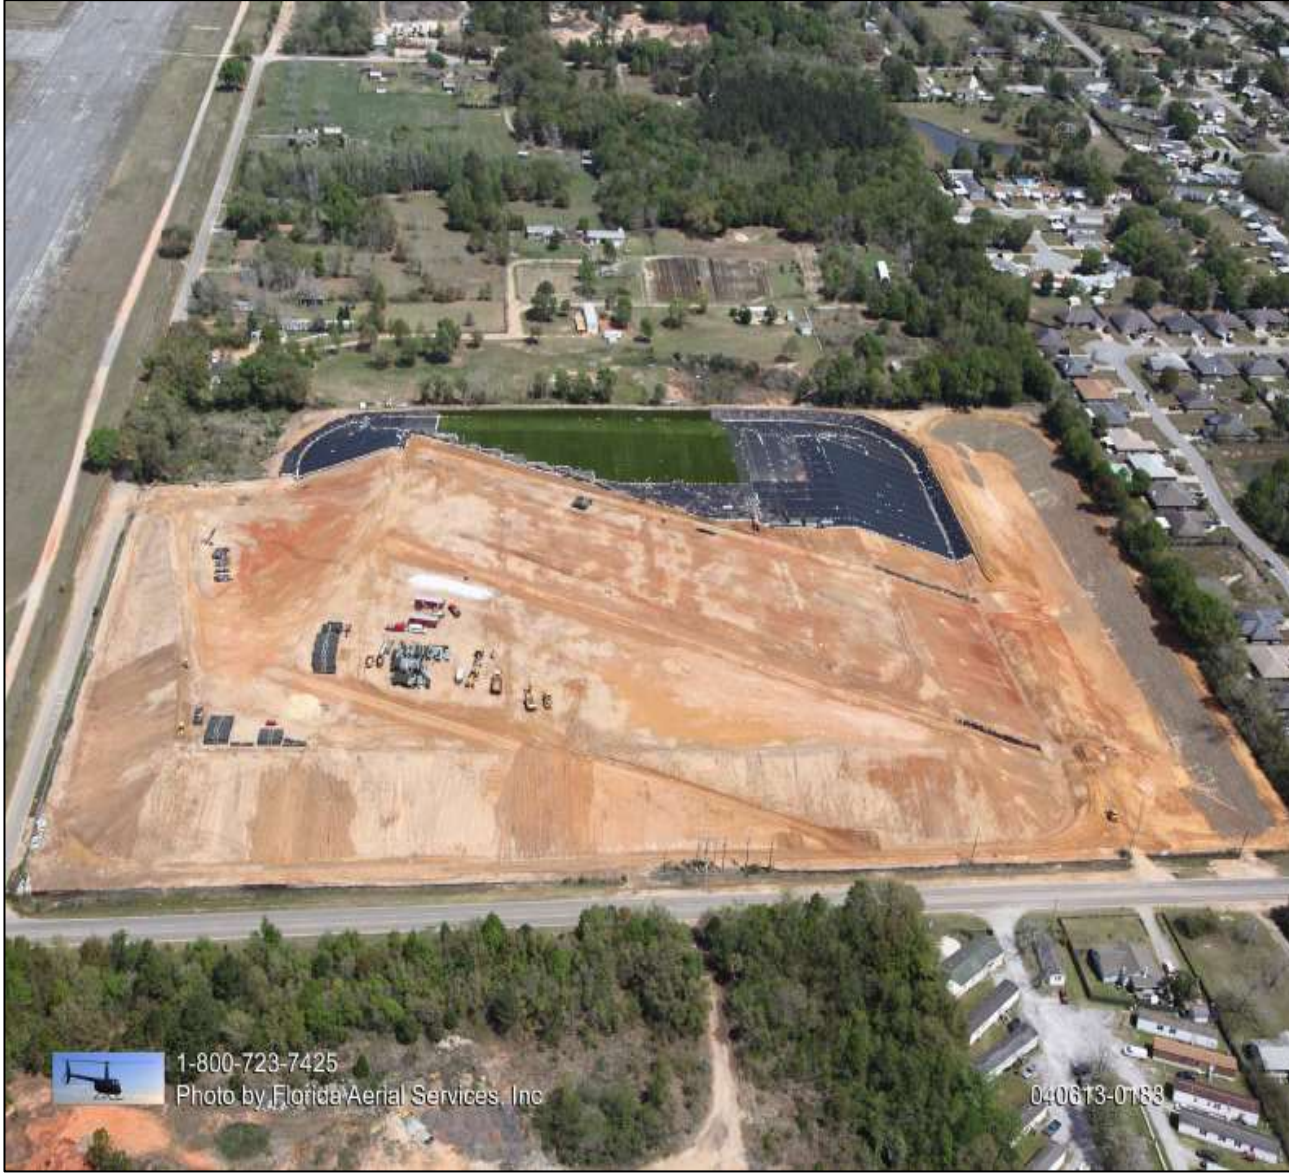
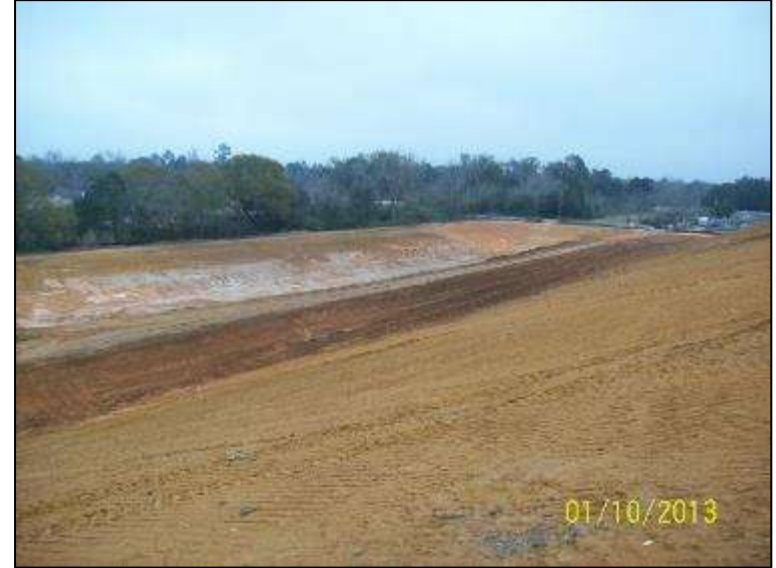
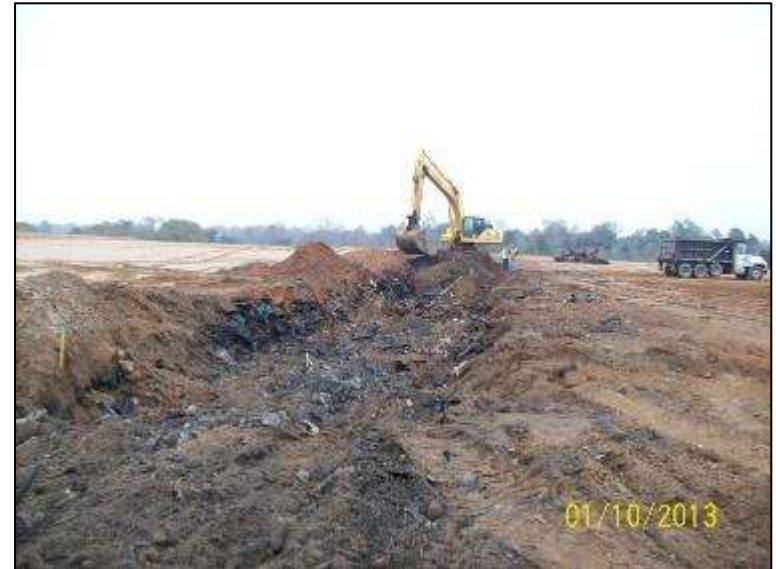
Cap Placement

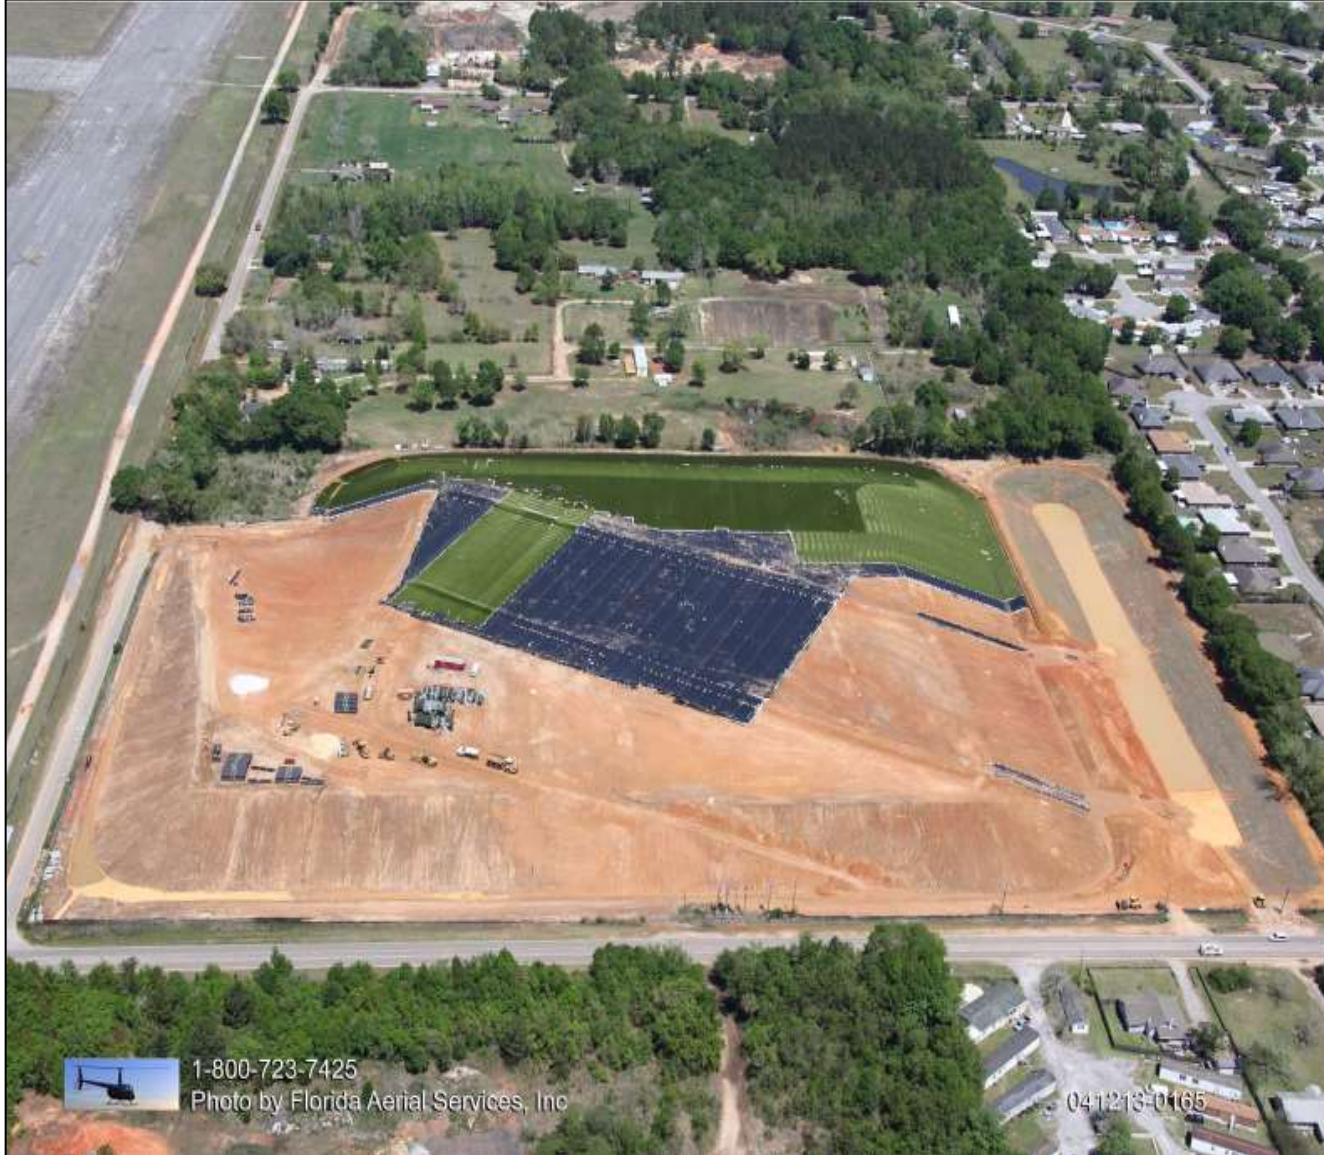
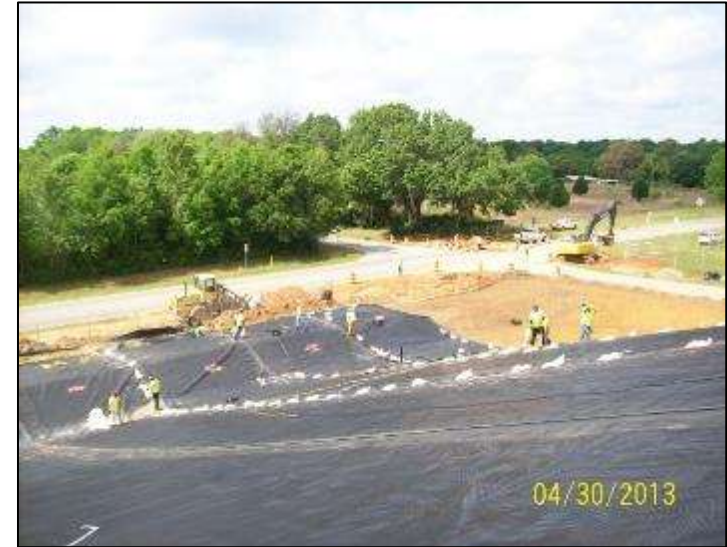
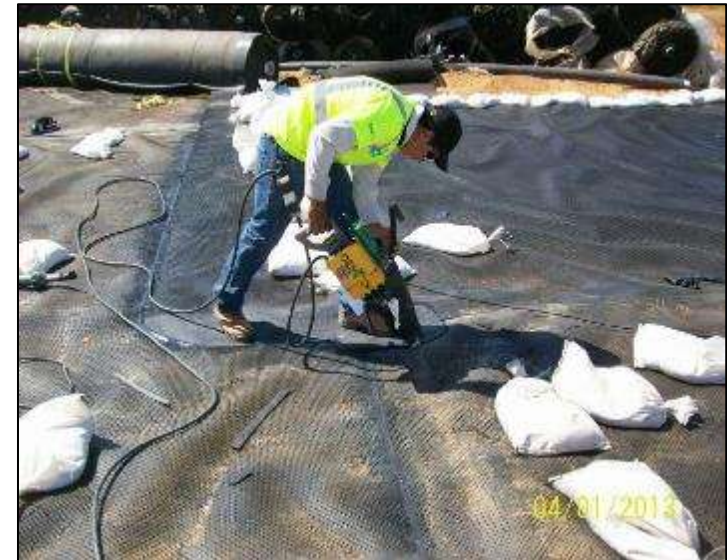
Cap Placement

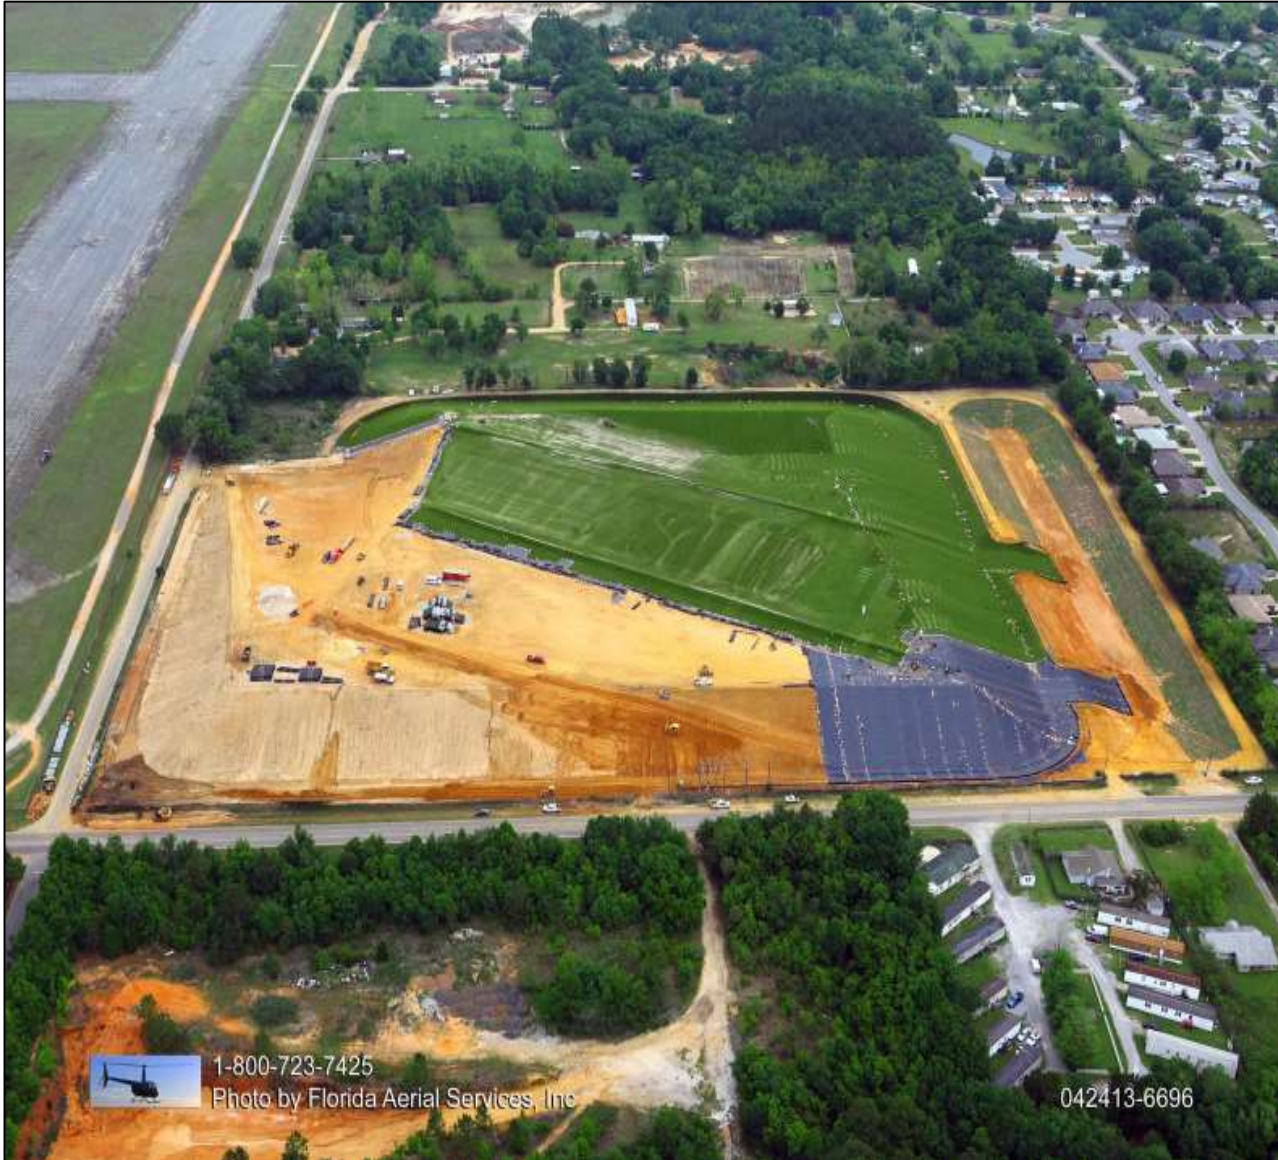
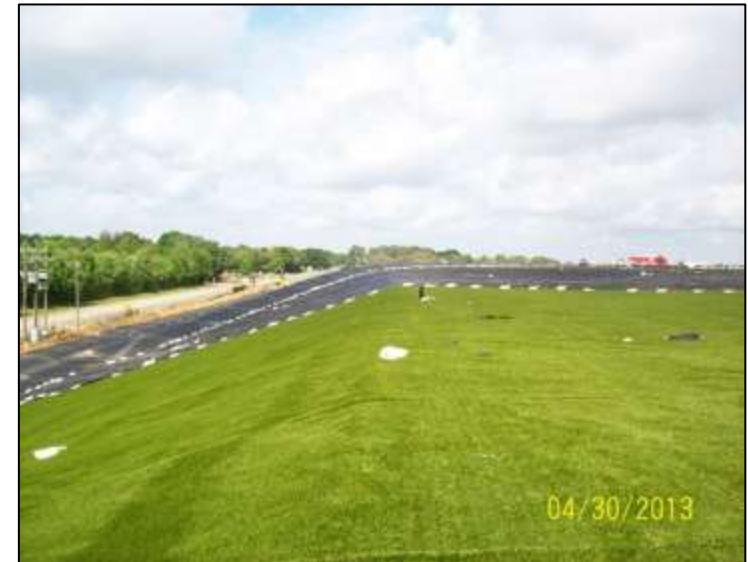
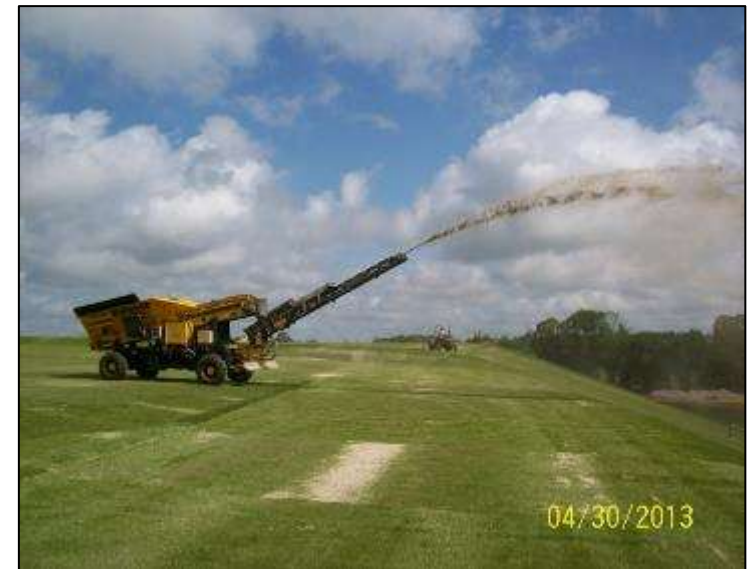
Cap Placement

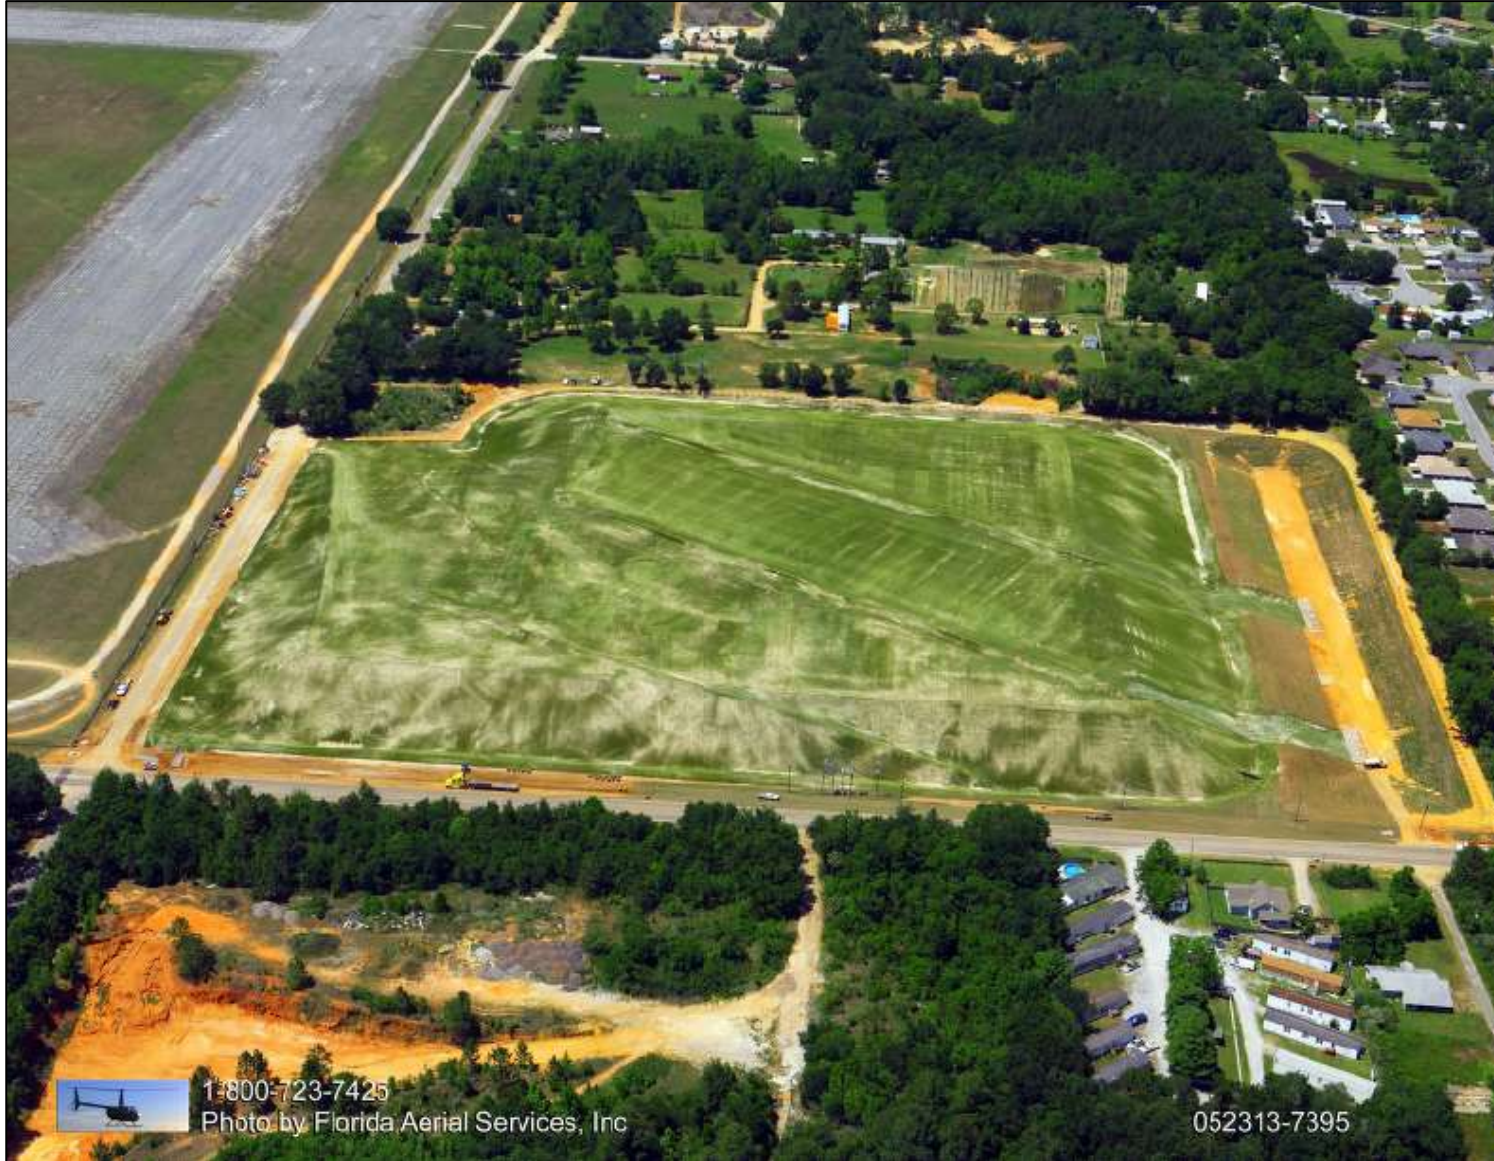
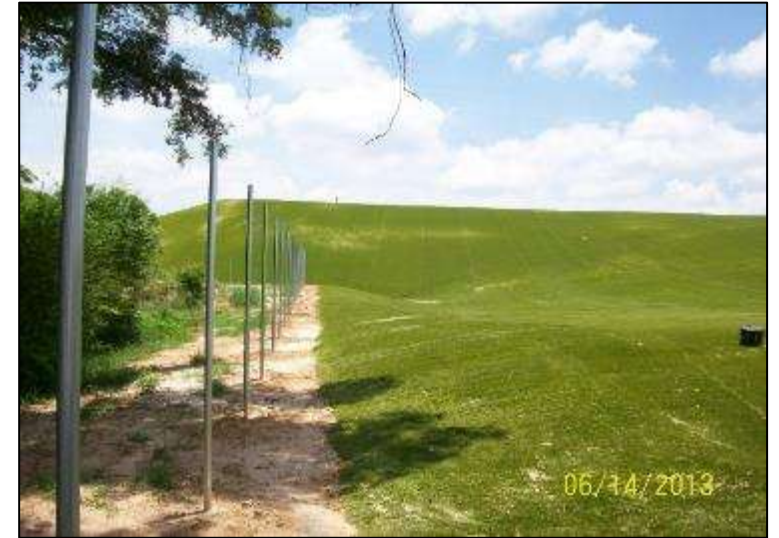
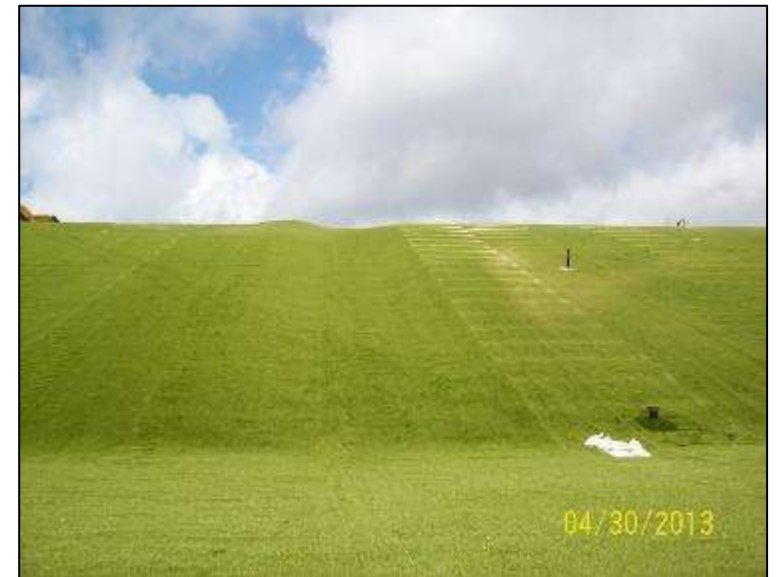
Cap Placement

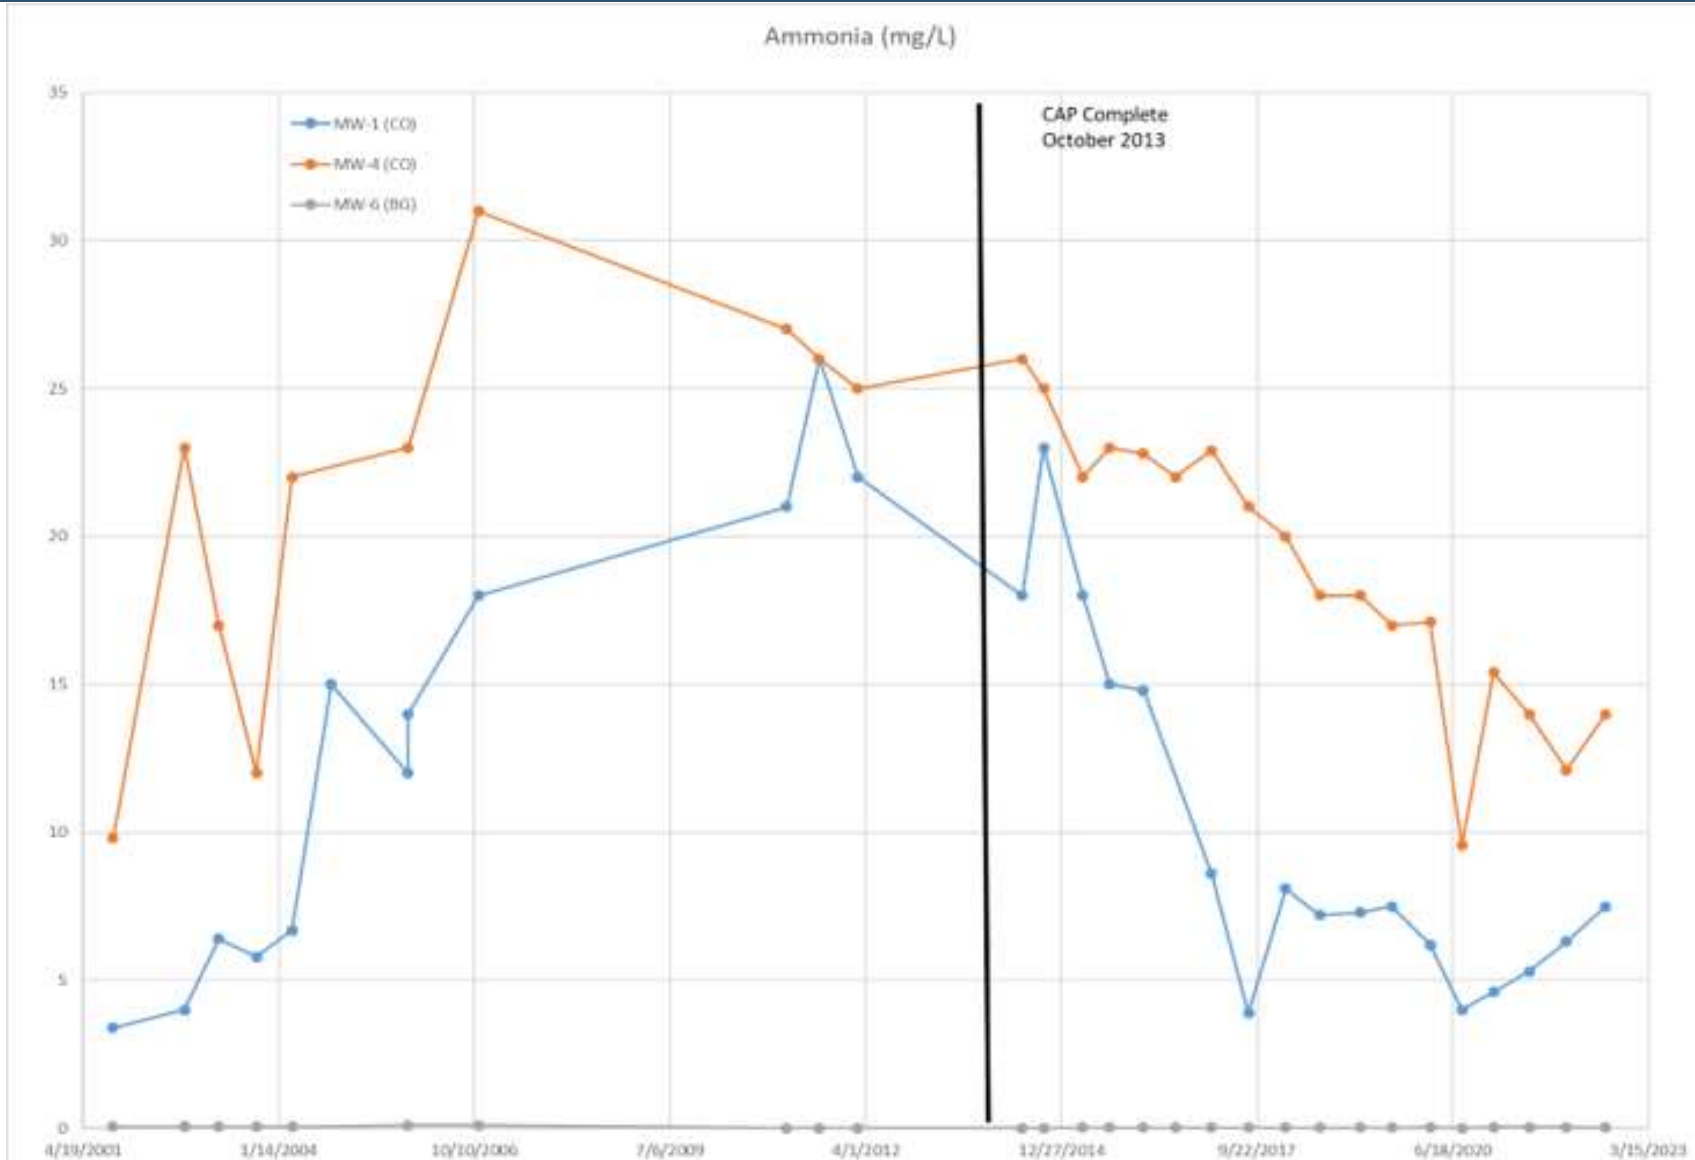
Impermeable Caps for Unlined C&Ds: Ammonia

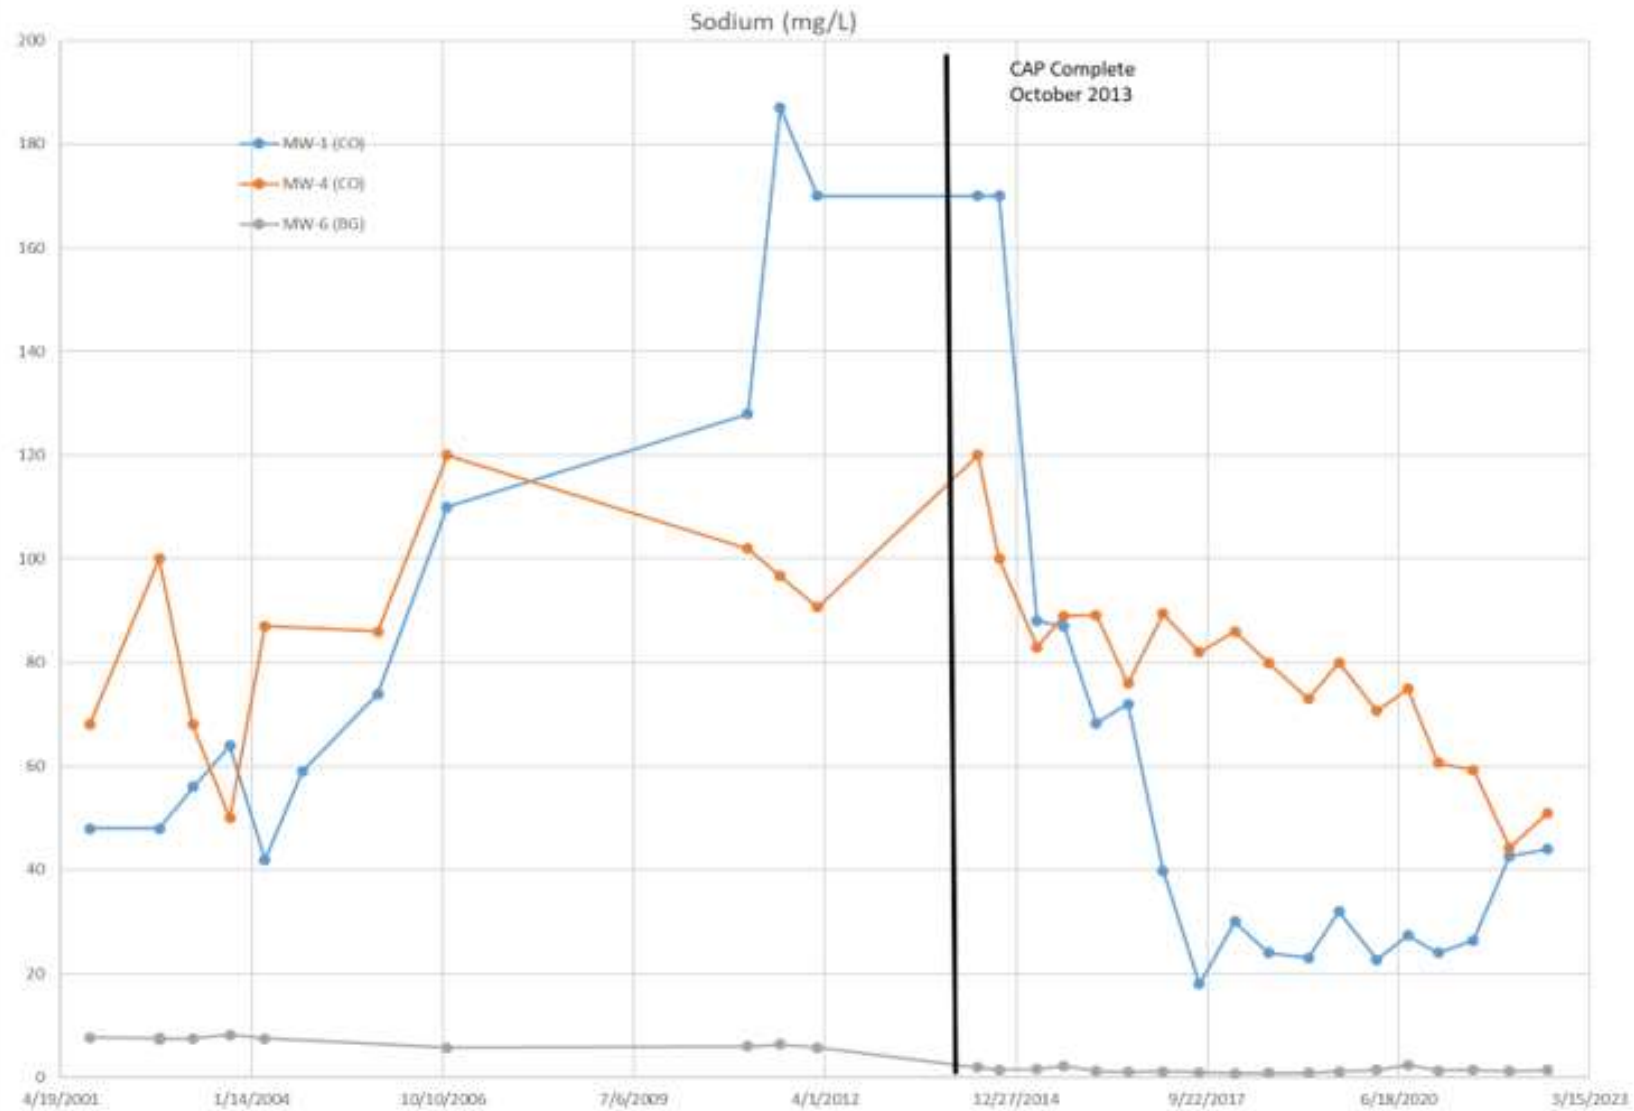
Impermeable Caps for Unlined C&Ds: Sodium

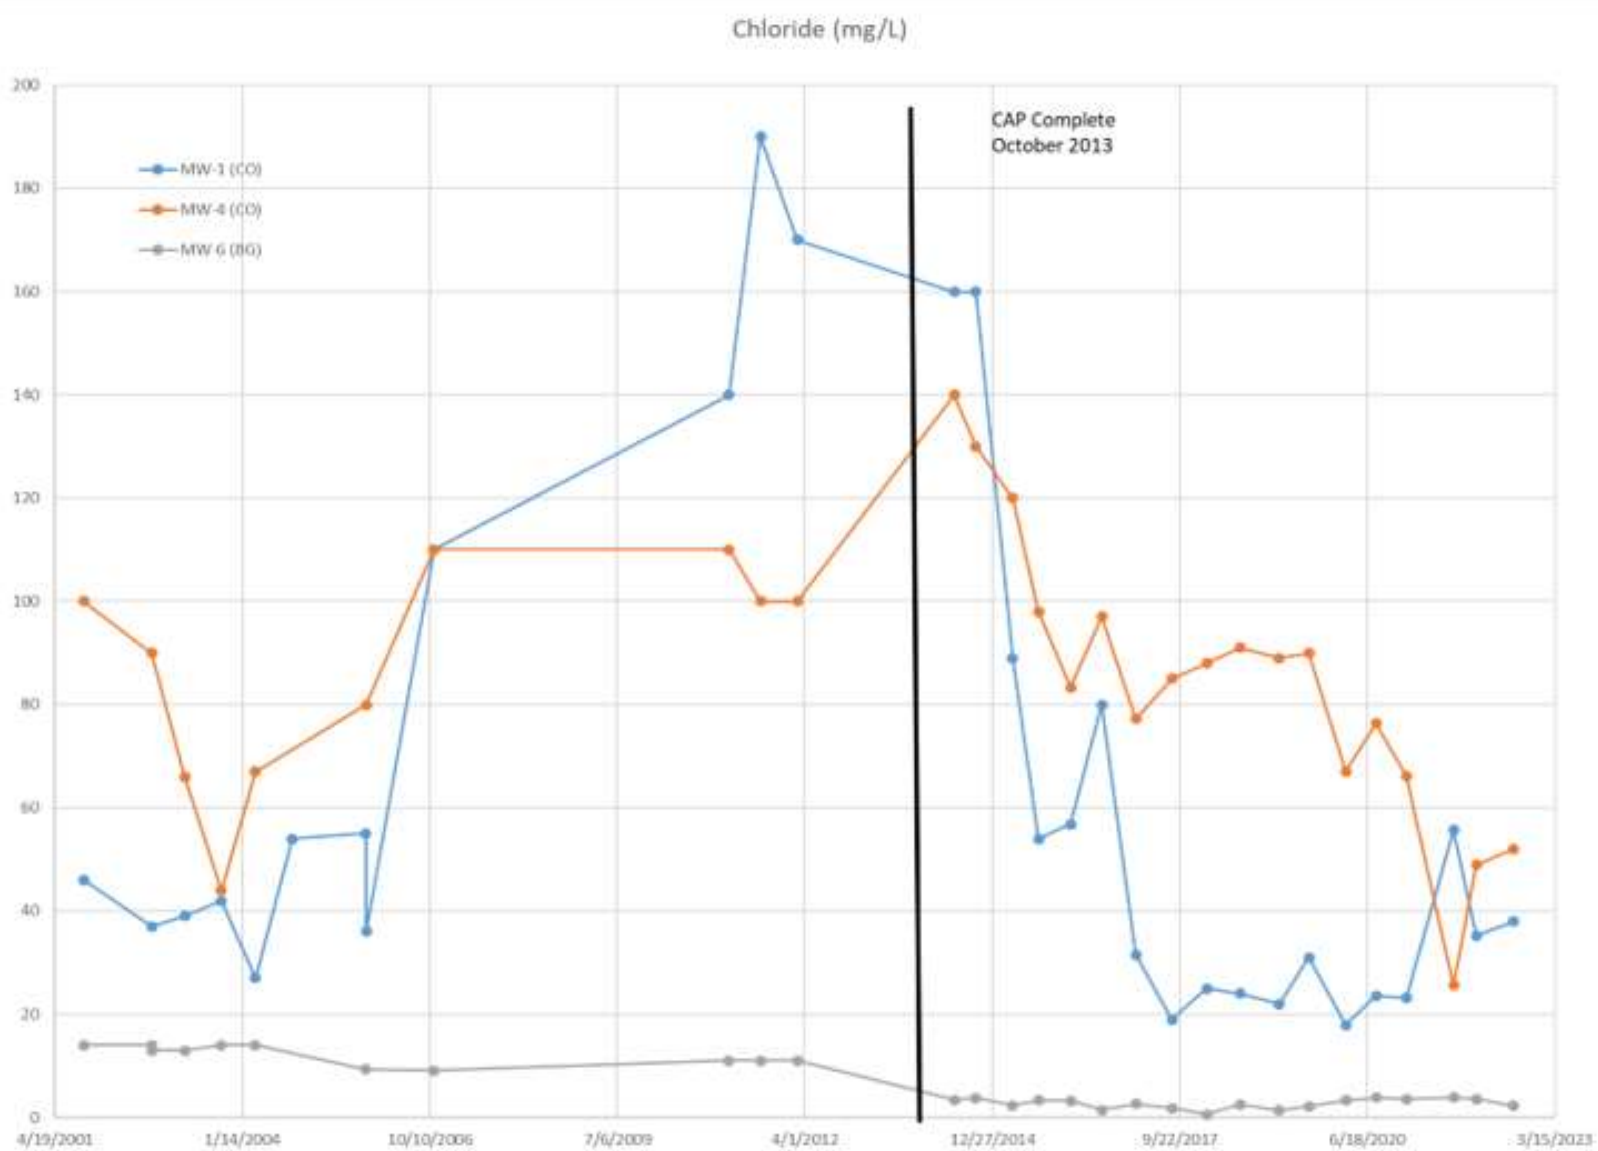
Impermeable Caps for Unlined C&Ds: Chloride

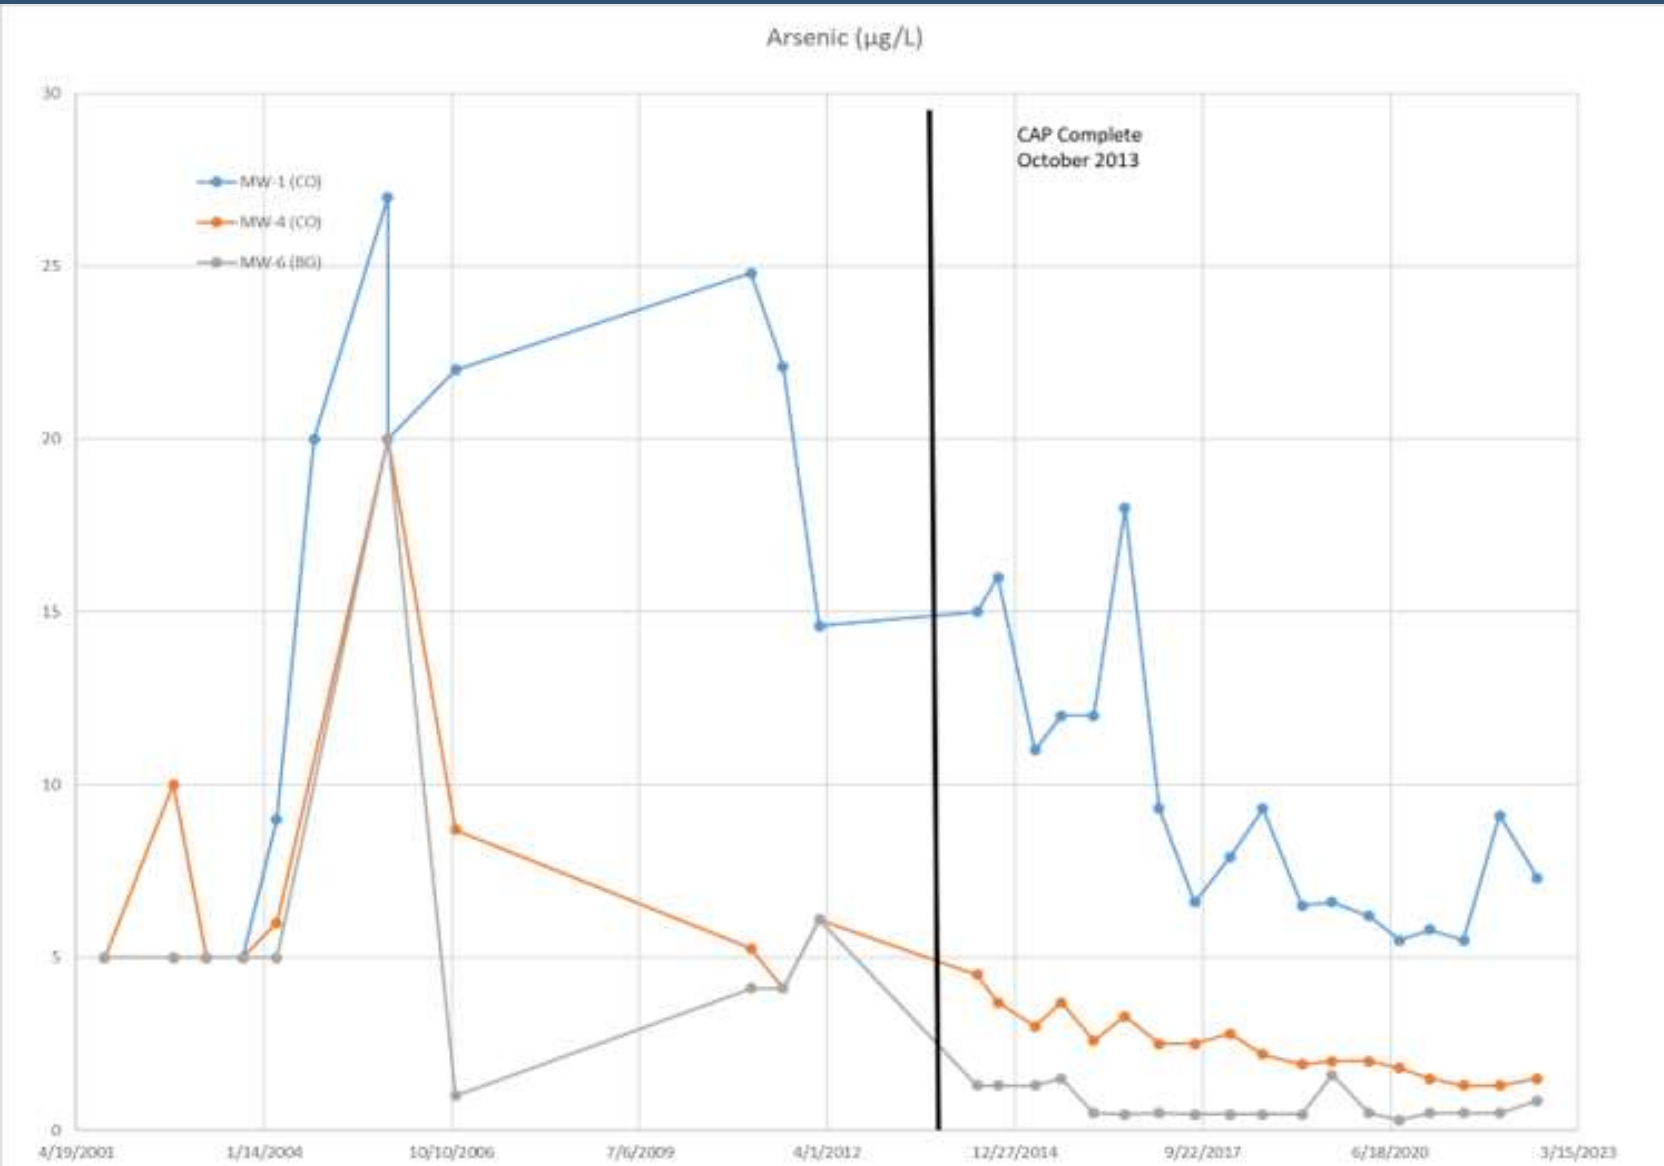
Impermeable Caps for Unlined C&Ds: Arsenic

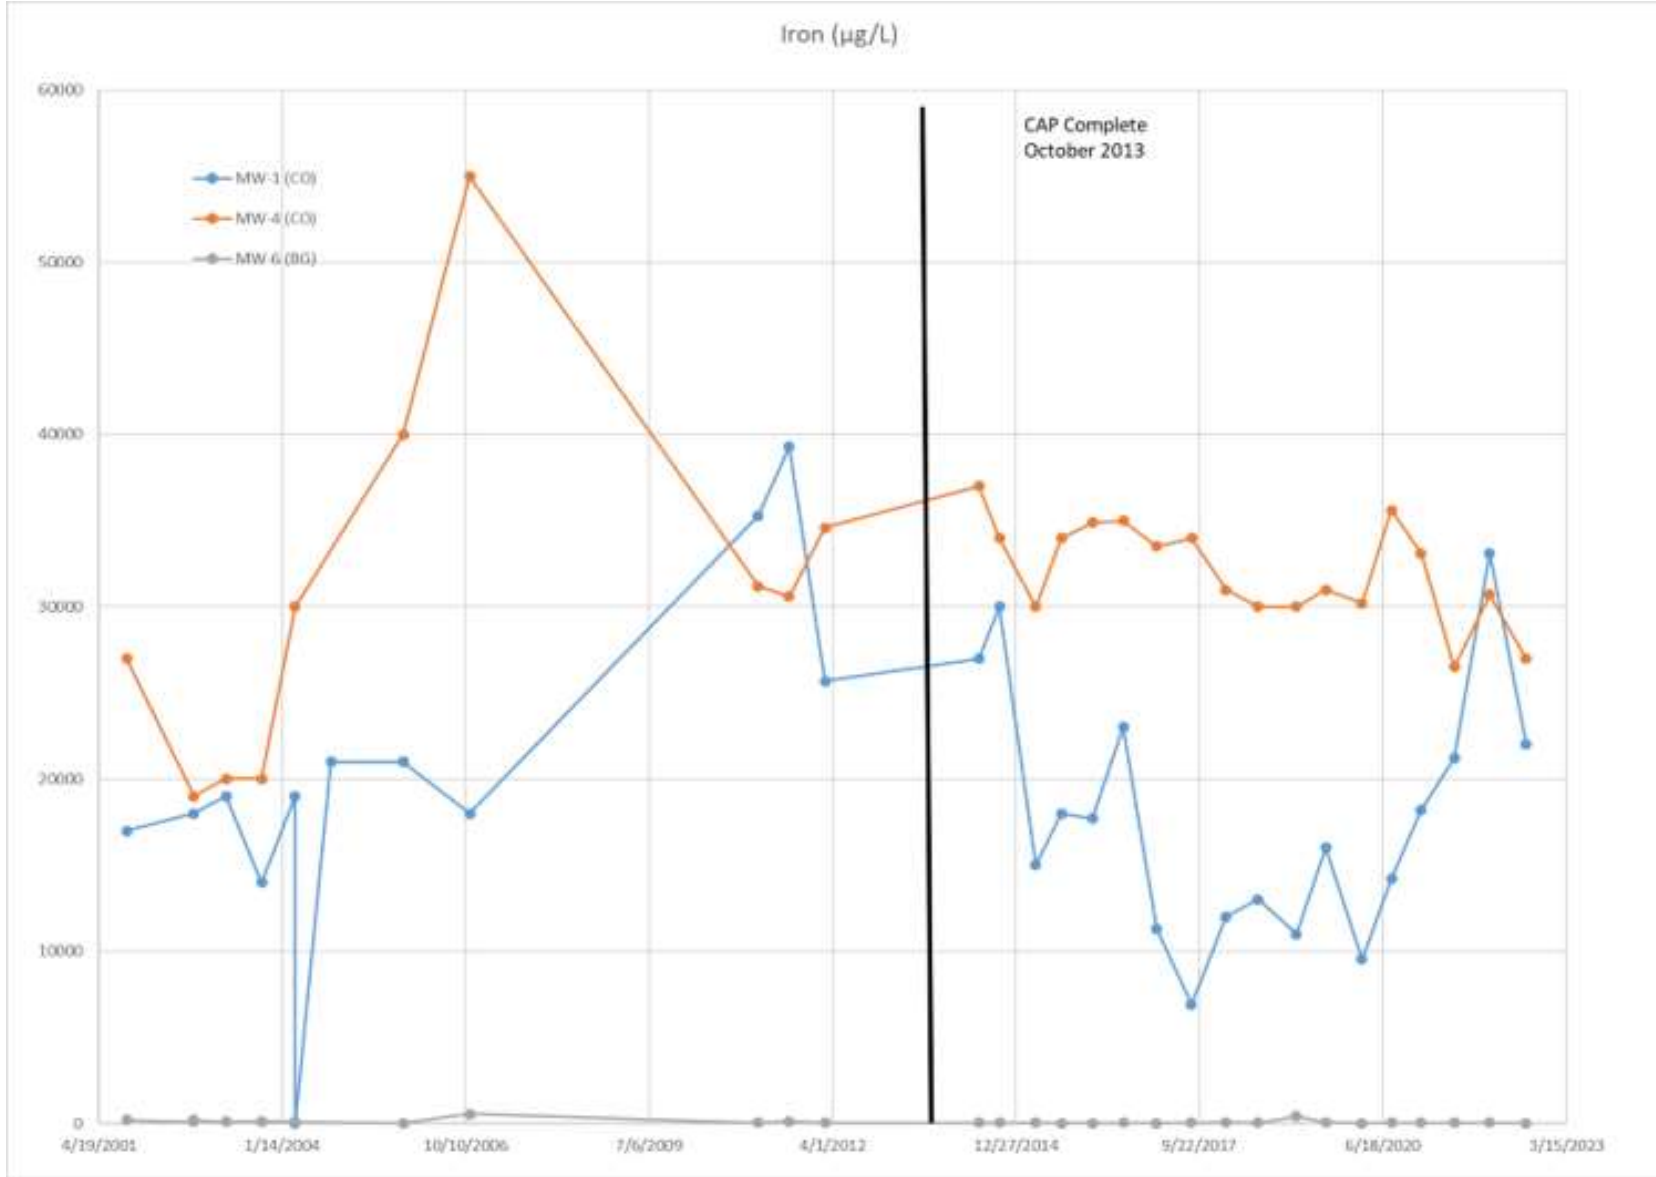
Impermeable Caps for Unlined C&Ds: Iron

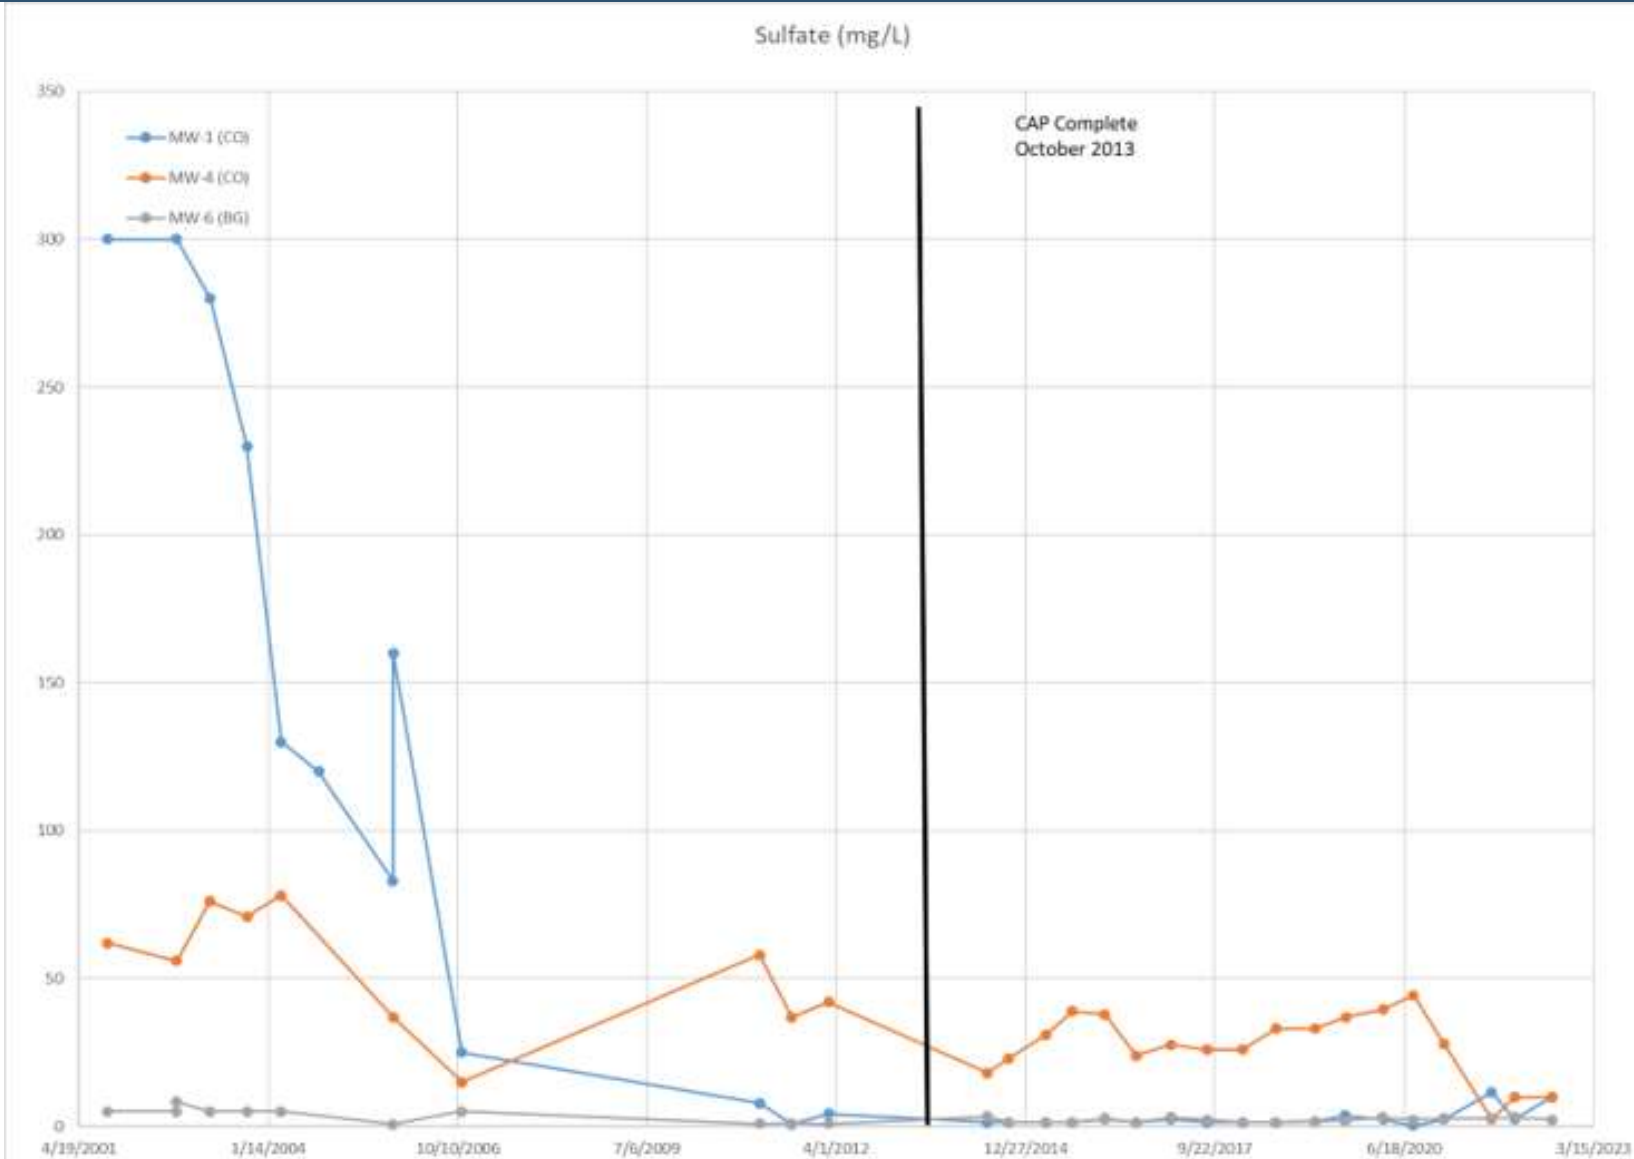
Impermeable Caps for Unlined C&Ds: Sulfate

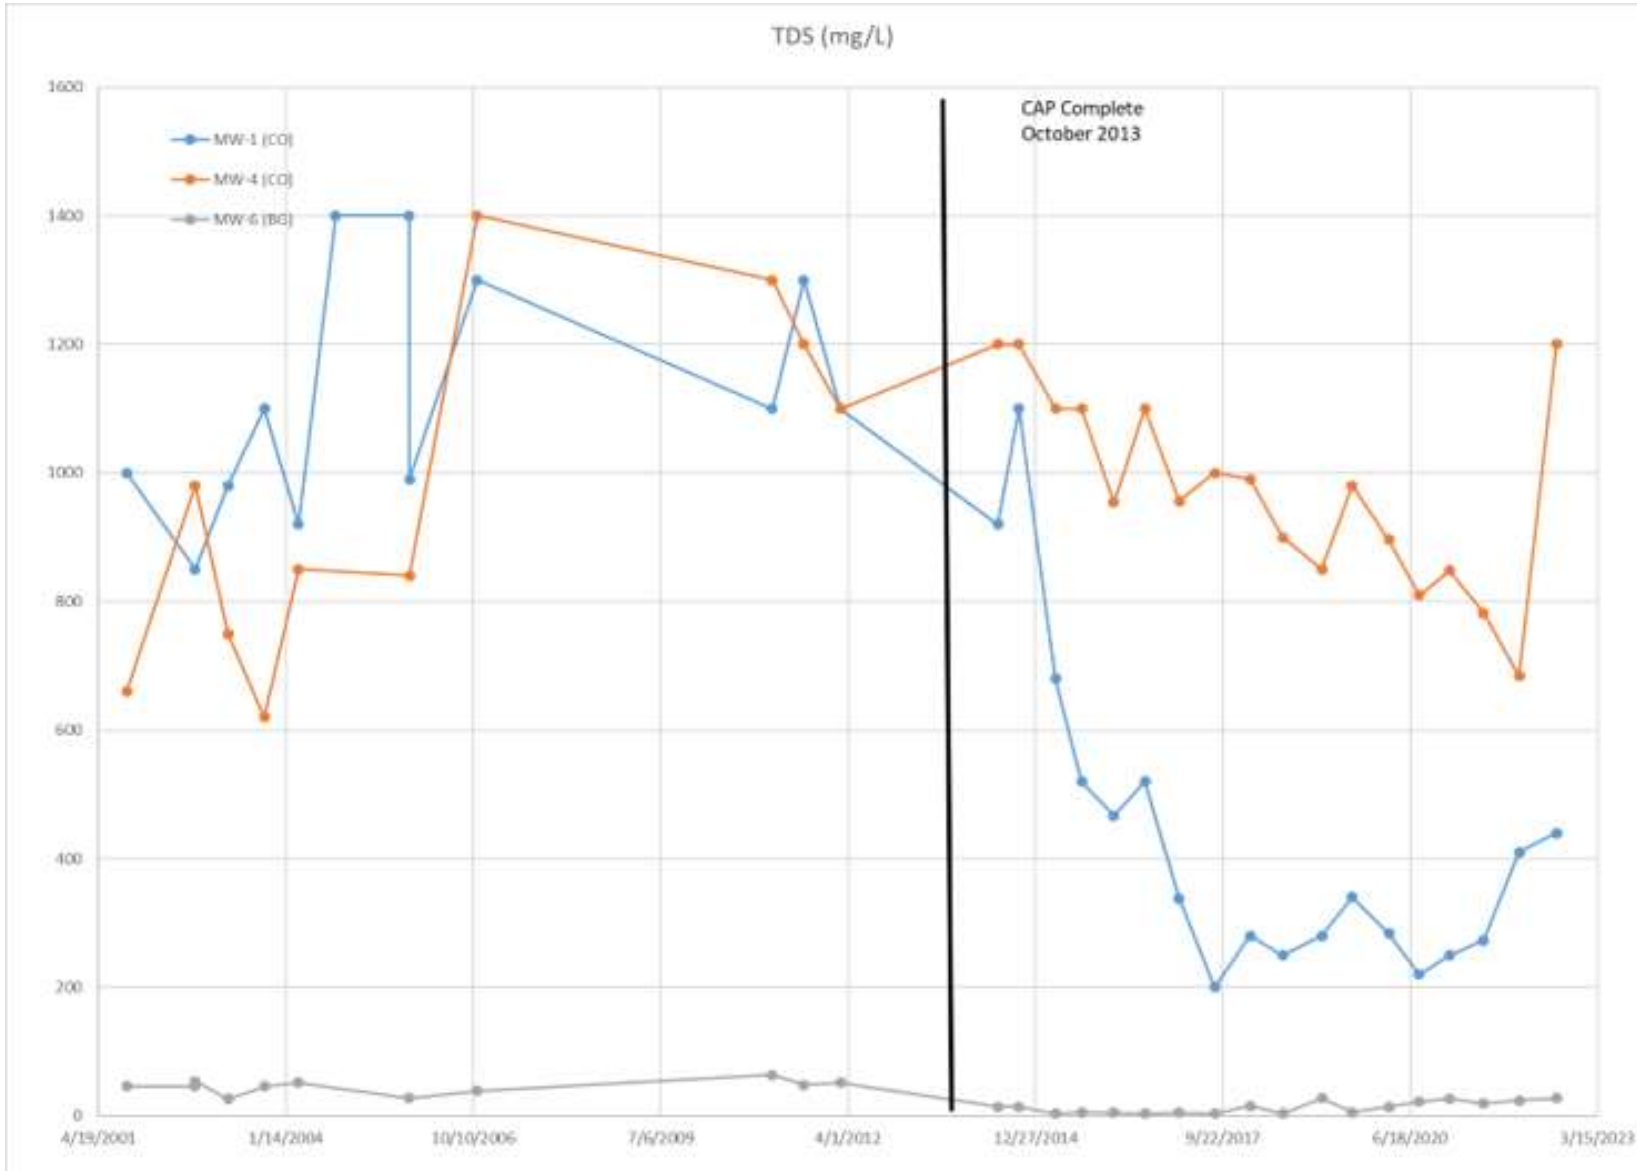
Impermeable Caps for Unlined C&Ds: TDS
