Unlined Construction and Demolition Debris Disposal Facilities

Dawn Templin, P.E.
Alex Webster, P.G.
Northwest District

Florida Department of Environmental Protection

Pensacola, FL | June 16, 2023

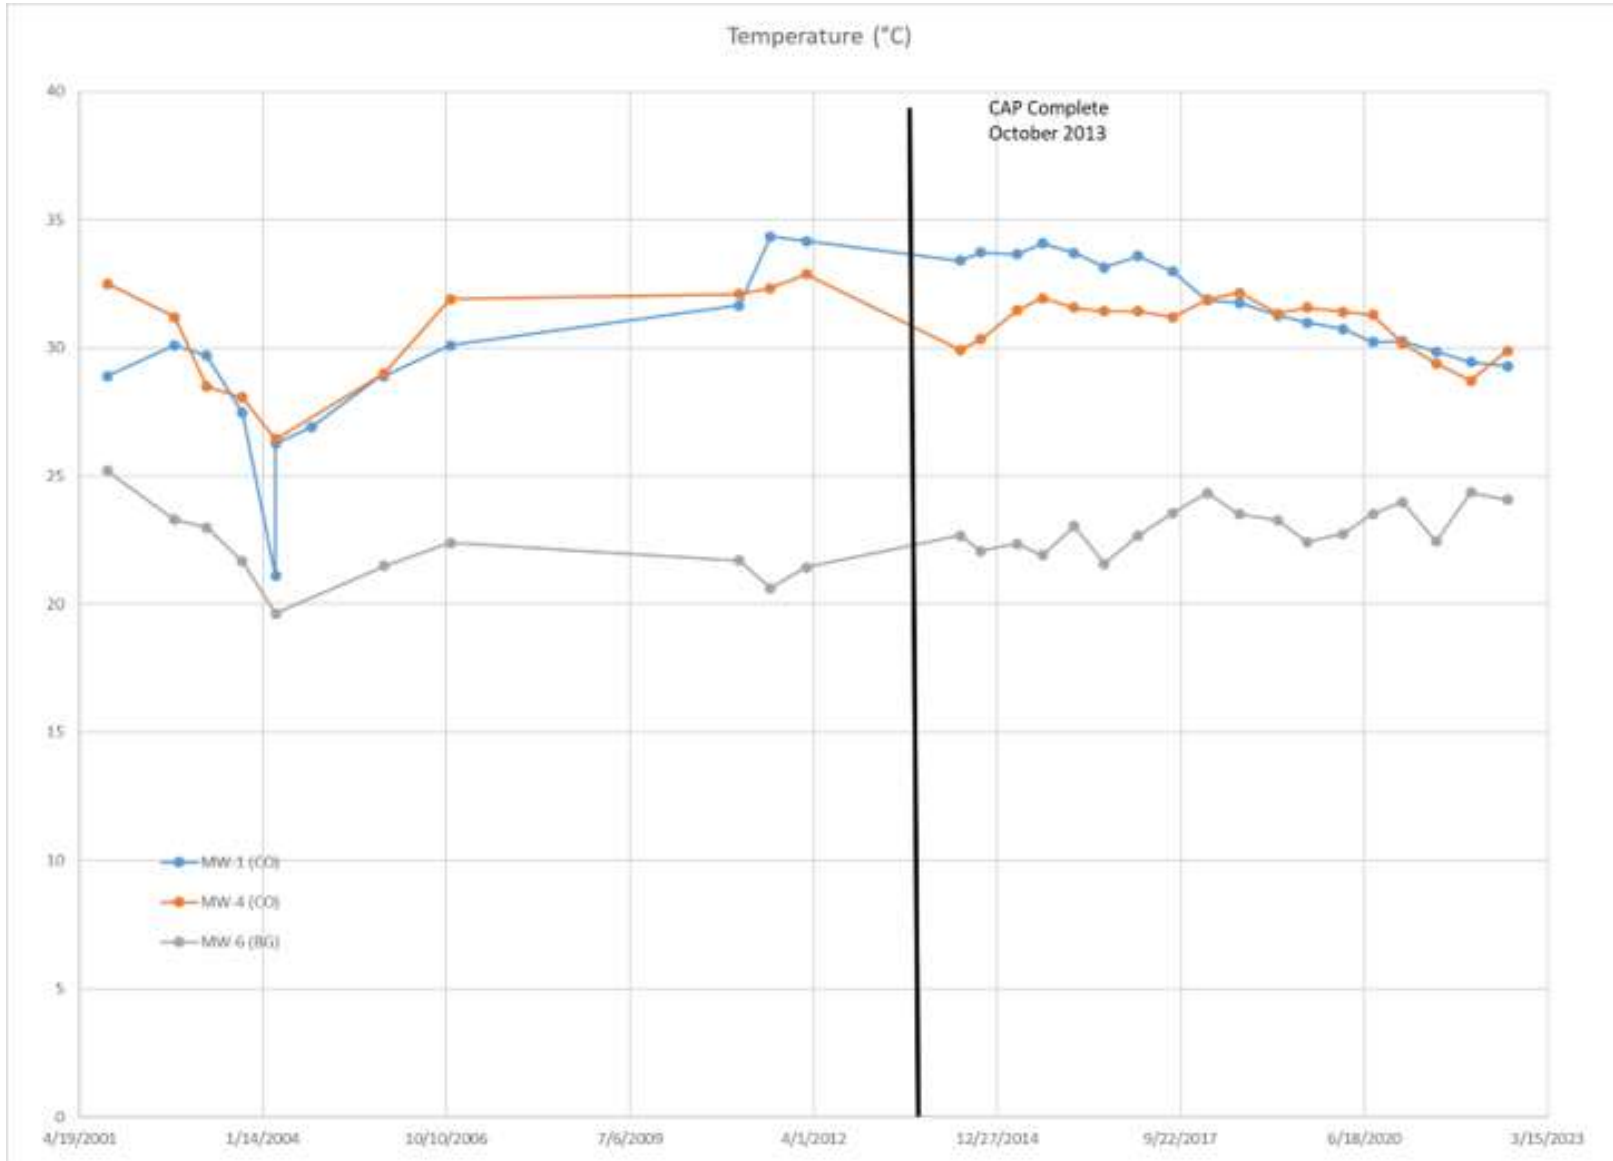
Impermeable Caps for Unlined C&Ds: Temperature
